On-site Inspection of PV Panels, Aided by Infrared Thermography

Elias Roumpakias, Fotis Bouroutzikas, Anastassios Stamatelos

Mechanical Engineering Department, University of Thessaly, Volos, Greece

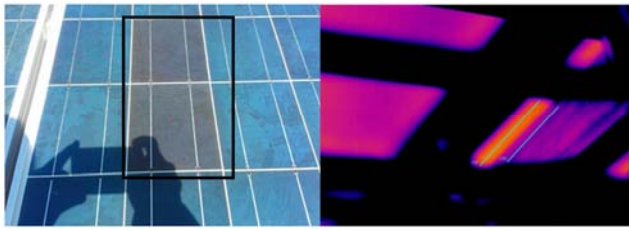
An example of this type of fault can be seen in Figure 3. This photo was taken on a 2-years old PV panel. As seen in the Figure, 2 cells from this panel are very dark-colored compared to the rest of the panel's cells. Infrared thermography shows that these cells have also higher temperature than the rest of the cells. The faulty region is shown to the left of the Figure and the respective thermogram with the hot spot to the right. The temperature diagram produced from the processing software (Figure 4) indicates a temperature difference of 5°C between the faulty region and the neighboring cells. The thermogram was taken from the back of the PV panel. According to the literature, the most probable cause of a hotspot is the installation of PV cells with different characteristics on the same panel [21], [22]. During the 24-month operation of the PV park to-date, no significant deterioration in the efficiency was observed. Thus, one cannot conclude if the observed difference is due to a malfunctioning of the PV panel or to an initially darker color of the cell, or even to the onset of a hot spot.

Figure 3. Normal take of a PV panel (left) and the corresponding thermography (right) taken from the back side. The cells with different color can be clearly seen and the corresponding hotspot that appears.

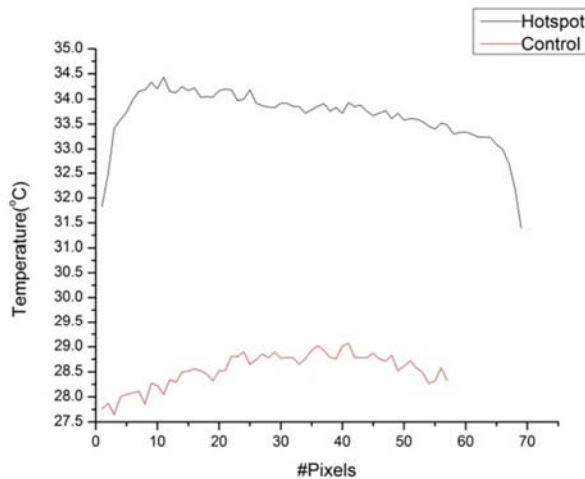
Figure 4. Temperature profiles along the two parallel, oblique lines shown on the thermogram of Figure 2.

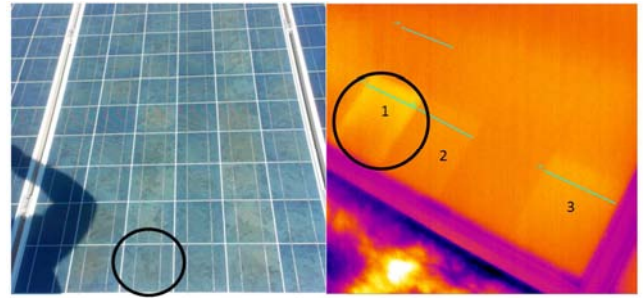
An observable difference in the external surface color of certain PV cells was observed in a number of panels. It should be mentioned that these are PV panels of the same manufacturer and the same age with the above-mentioned. This fault is due to the discoloration of the protective EVA (ethylene vinyl acetate) membrane, which is placed in-between the cells and the protective glass. A certain degree of discoloration (yellowing) is observed in the photo at the left of Figure 5. This yellowing of the membrane is observed in a large part of the panel's surface. According to other researchers [23], [5], [24] this phenomenon is caused by a change in the membrane's chemical composition due to the effect of UV radiation and high temperatures. Several cells with increased temperature can be seen in the respective thermogram to the right of Figure 5. The temperature difference varies in the range from 4.5°C (cell #1) to 2.5°C (cells # 2, 3), as shown in the respective temperature profiles of Figure 6. The thermogram was taken from the front of the panel, because shooting from the back was hindered by the frame. It is possible that other regions exist with increased temperature. Moreover, the temperature difference could be higher than the above mentioned. This is a typical fault observed in several PV panels in this installation.

Figure 5. Normal photo of a PV panel (left) and the corresponding infrared photo (right). The cells affected by discoloration (yellowing) can be clearly seen and the corresponding hotspots that appear.

from this series could be due to the fact that several panels from this series present a yellowing of the EVA membrane. The diagram presented in Figure 20 shows the electricity production during the 3rd of March 2015, which was the specific day when the inspection with thermography took place. During the time interval from 11.00-13.00 where the infrared thermograms were received, it is apparent that the inverters Inv1, Inv6 produce less power. In order to confirm that this is a systematic deviation in performance, Figure 21 presents a diagram of the electricity produced during the first 10 days of March. The trend is clearly observable for all days.

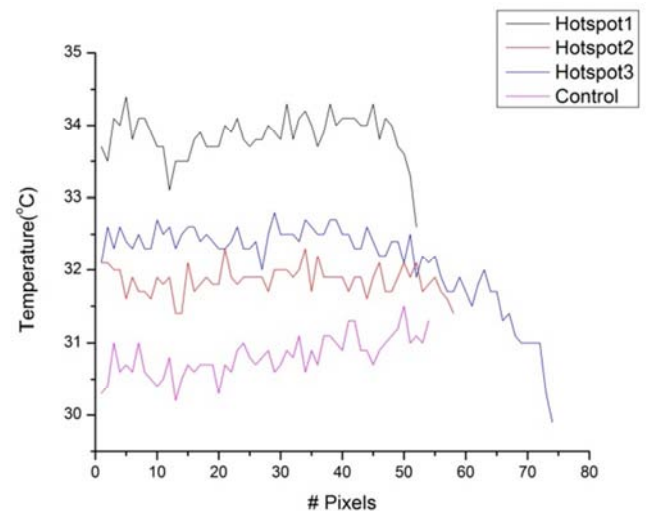
Figure 6. Temperature profiles along the six parallel lines shown on the thermogram of Fig. 5.

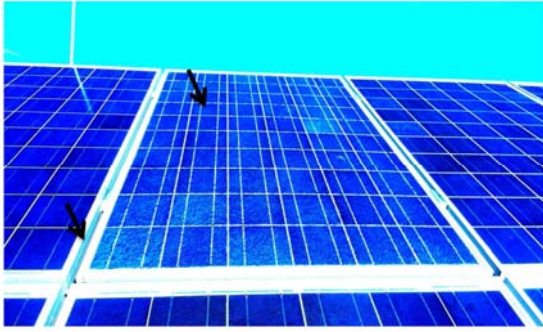
A PV panel with apparent breakage of its protective glass was spotted in the same installation. A photograph is presented in Figure 7. The protective cover has broken in two places and cracks propagated to cover most of the panel's surface. This resulted in the intrusion of humidity inside the panel structure. The results from infrared thermography (Figure 8) revealed three hot spots with significantly higher temperature than the neighboring cells. The temperature difference varies from 22 to 40°C (Figure 9). The image was taken from the front, in order to show a panoramic view of the panel. Closer thermograms taken from the back, revealed significantly higher temperature differences of the order of 50 °C (Figure 10). This difference could be attributed in part to errors due to diffuse radiation from the background, during the front shootings. Moreover, the closer thermograms reveal a more detailed temperature distribution inside the cell, with regions of different temperatures in the same cell, with differences as big as 35°C. These could be due to the existence of cracks at the cell's surface, a fact that could not be confirmed due to the specific position of the panel at the highest horizontal line that was not easily accessible. The specific thermal behavior is explained in the literature [24].

Figure 1. Panel with mechanical damage (protective glass) in two areas highlighted by arrows.

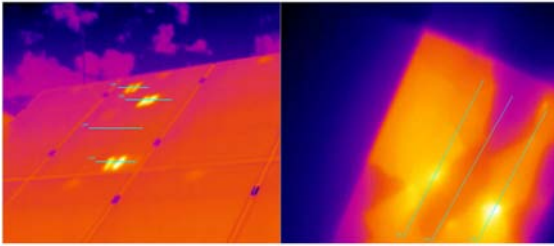
Figure 2. Thermographic view taken from the front of the problematic PV panel with the cracked glass on the left. Close up view taken from the rear side of the same panel on the right where areas with different temperature are shown.

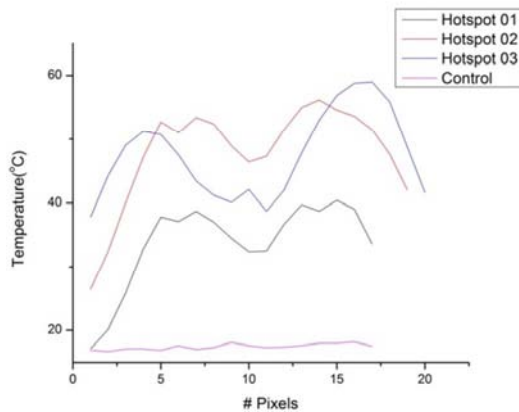
Figure 9. Temperature profiles of the problematic areas of the panel of fig. 7-8.

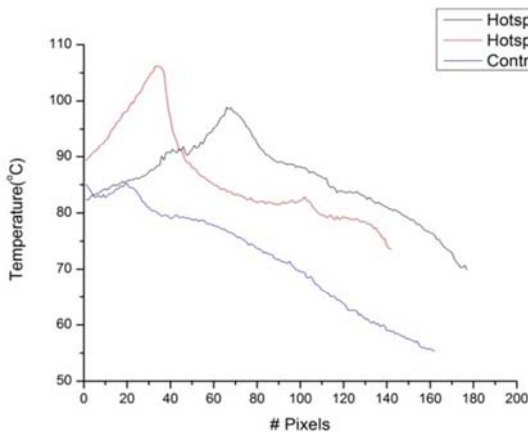
Figure 10. Thermographic profiles of the back side of the panel of fig. 7-8.

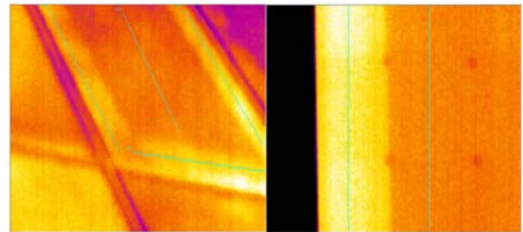
According to the findings of other researchers [11], it is possible to observe and record the phenomenon of PID by means of infrared thermography. A series of measurements were carried out in a roof-top PV installation to confirm these findings. Optical inspection of the installation did not reveal any possible faults. However, the results of the infrared thermograms showed that a significant percentage of the installed PV panels suffered from PID. Some of the findings are observable in Figure 11. The phenomenon is especially observable with the cells that are closer to the metallic frame. The temperature difference is in the range of 3 to 4°C (Figure 12). Infrared thermograms were received also from the back side for confirmation (Figure 13). Again the processing of the thermograms indicated a temperature difference of 3°C.

Figure 11. Thermographs of PID affected panel. Takes from the front (left) and back side (right).

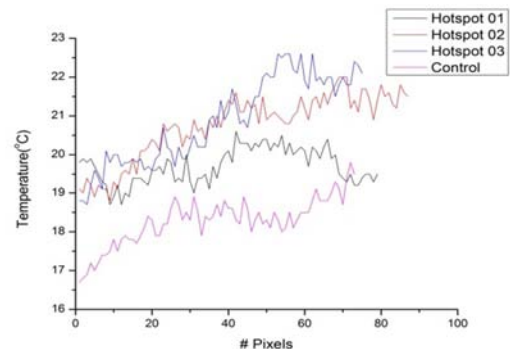
Figure 12. Temperature profiles of the front side of the PID affected panel shown on Fig.11.

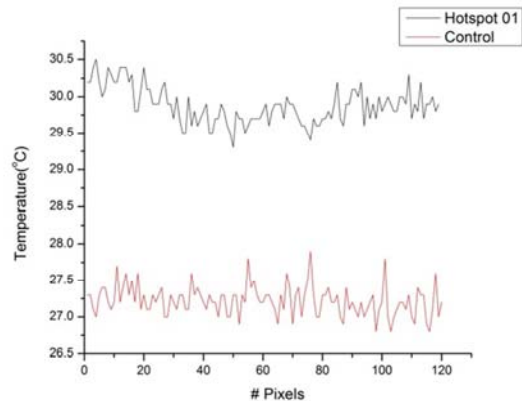
Figure 13. Temperature profiles of the back side of the PID affected panel shown on fig.11.

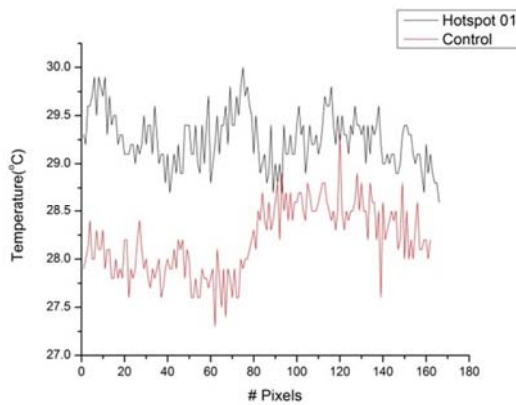
Several hot spots were found during inspection in two different PV installations, in cells with no visible faults (Figures 14, 16). The temperature differences observed were of the order of 3°C (Figures 15, 17, 18). It is not yet confirmed if the observed hot spots point to a fault in its initial stages that is not yet visibly apparent, or if the specific type of fault is not visible to the naked eye.

Figure 15. Temperature profiles of the two parallel lines seen on the thermograph of fig.14.

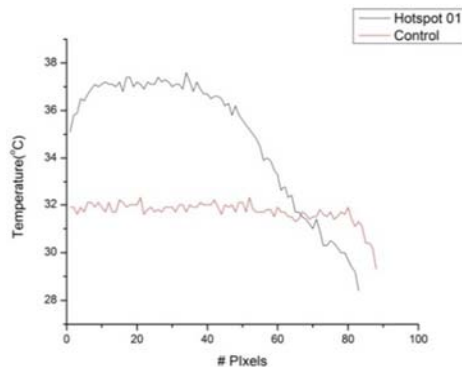
Figure 17. Temperature profiles of the two parallel lines seen on the thermograph of fig.16.

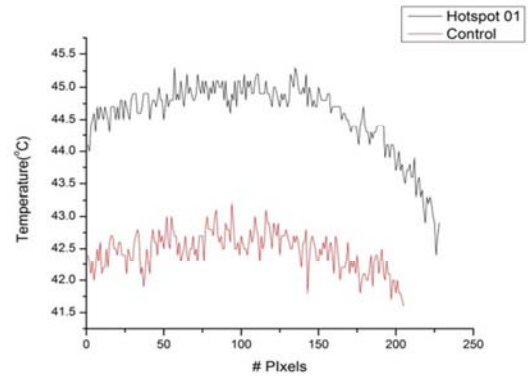
Figure 18. Temperature profiles of the two parallel lines seen on the thermograph of fig.16.

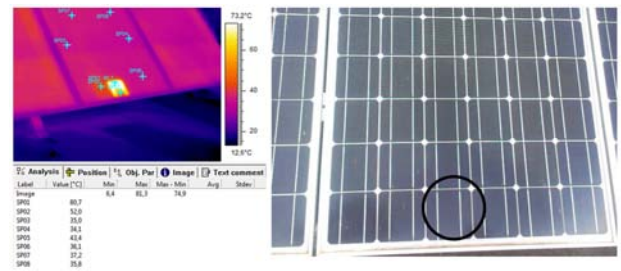
Another case with a remarkable temperature difference without apparent optical fault is the image of figure 19. In the specific PV panel, most of the cells have similar temperatures except for one cell that has a temperature of 80°C. However, no performance decrease is observed yet. Monitoring of this case could lead to future results of this hot spot.

Figure 19. IR images of pv panel that has not optical fault , however it has an a cell with remarkable temperature difference.
