# Shear Zone Treatment at Dam Foundation Level

Ashutosh Anand, Somesh Kumar, Vivek Tripathi

Designs & Research Wing, Central Water Commission, New Delhi, India

Ashutosh Anand, Somesh Kumar, Vivek Tripathi. Shear Zone Treatment at Dam Foundation Level. *American Journal of Civil Engineering*. Vol. 5, No. 6, 2017, pp. 352-357. doi: 10.11648/j.ajce.20170506.16

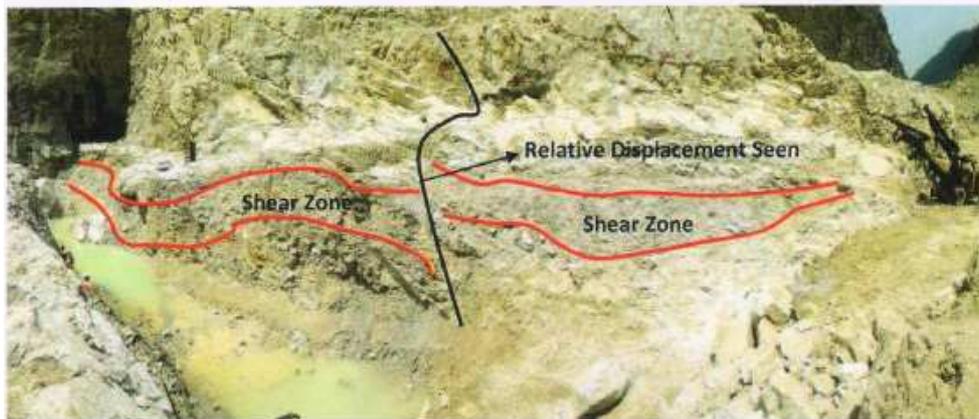
Figure 2. Shear Zone at Left Side of Excavated Trench.

blocky rock mass. Two major shear zones were encountered during the mapping of the trench area. The major shear zone is dipping towards left bank side with  $15^\circ - 68^\circ$  towards  $N 40^\circ - 80^\circ$  direction, with 0.5 m to 1.5 m thick crushed rock mass with 10 to 20 cm thick clay gouge. The affected area of the shear zone is about 1 to 2 m having highly fractured and jointed rock mass with thin shear seams at places (Figure 2).

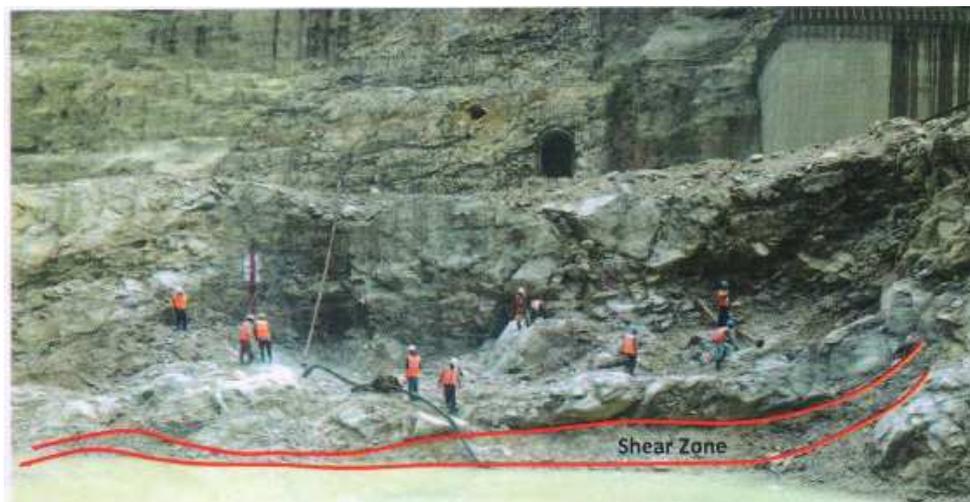
Figure 3. Shear Zone Right Side of Excavated Trench.

The cover between the competent rock mass and shear zone in the resting bench at left side of the shear trench is about minimum 0.5 m at dam axis to maximum 2.5 m at 36 m d/s of the dam axis, the cover between bench and shear zone increases towards hill side due to the dip and dip direction of the shear. Another shear zone dipping towards right bank side with  $20-45^\circ$  towards  $N 190^\circ$  direction, with 0.2 to 0.8 m thick crushed rock mass with 5 to 10 cm clay gouge was observed. The affected area of shear zone varies between 0.5 to 1 m with minor shear seams (Figure 3).

with minor seams Quartzo Feldspathic Gneiss. The rock mass is slightly weathered to fresh. It is observed that the shear zone at left side of the excavated trench is pinching towards downstream side and gets bifurcated in upstream portion. The thickness of the shear zone at right side reduces towards downstream side and finally merges with left side major shear zone. The Q value of the rock mass ranges from 1.5 to 4.5 class IV to III and in the shear zone portion it varies from 0.1 to 0.08 class V. The Rock Mass Rating (RMR) varies in jointed and blocky rock mass from 20 to 45 and GSI varies 15 to 40 where as in shear zone RMR ranging from 10 to 15 and Geological Survey of India (GSI) 5 to 10.

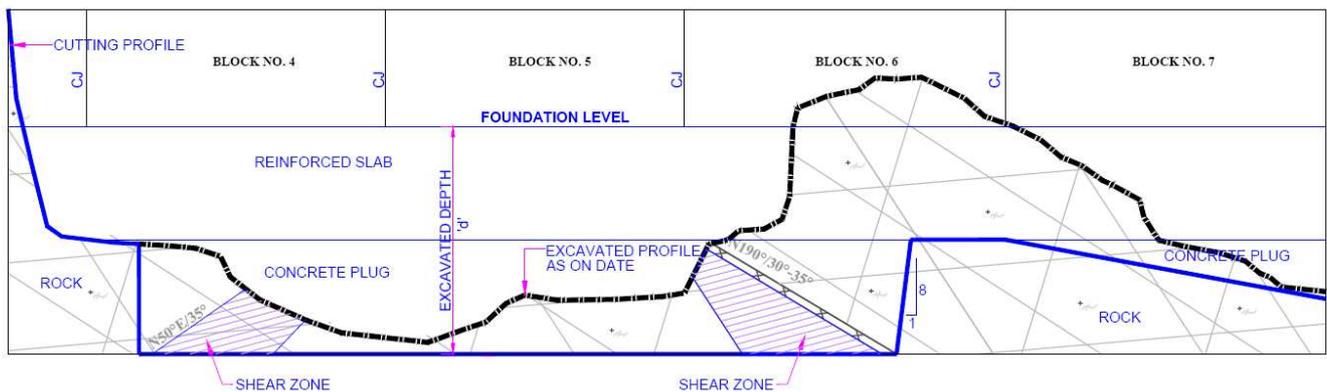
Figure 4. Cutting Profile at Shear Zone Affected Area.

All the weak material along the length of shear zone has been excavated to the depth ‘d’ i.e reinforced slab + concrete plug (shown in Figure 4) which were decided as per theoretical studies made by United State Bureau of Reclamation (USBR) in connection with foundation problem encountered at Shasta and Friant dams, have led to the development of the following approximate equations for determination of depth of treatment of transverse seams.

The cutting profile with stable rock slopes provided at the shear zone affected area (Figure 4).

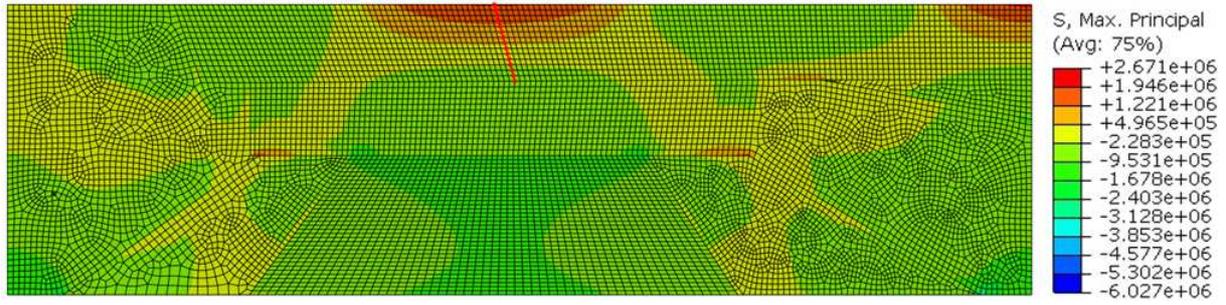
Figure 7. Maximum Principal Stress Contour.

The maximum principal stress contour plot (Figure 7) shows that the maximum tensile stress is coming over the top of slab and it reduces with the depth of slab.

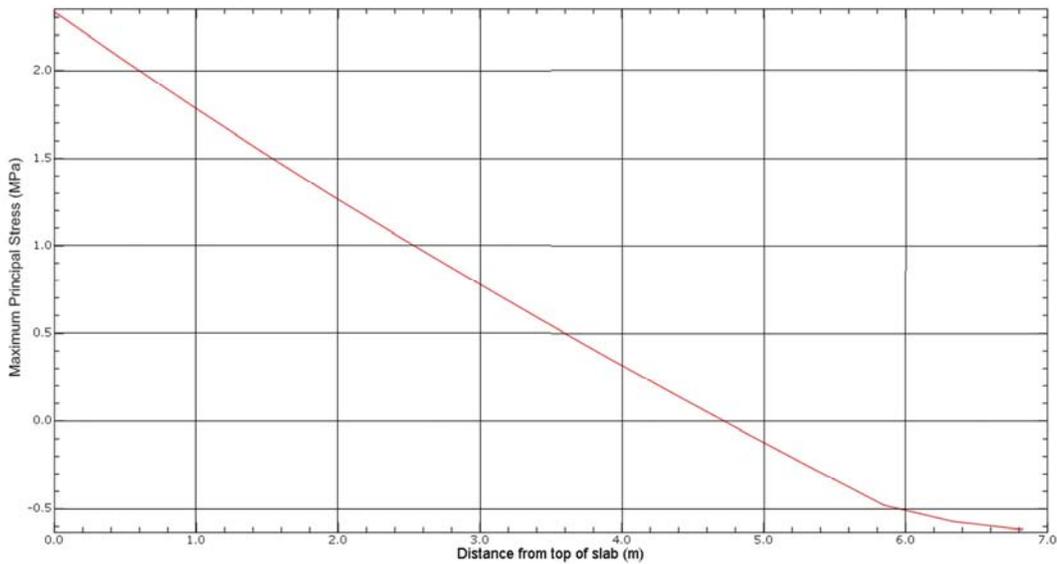
Figure 8. Plot of Maximum Principal Stress,  $\sigma_{11}$  (MPa) vs Distance from Top of Slab (m).

The value of the maximum tensile stress 2.67 MPa decreases from the top and becomes zero at a depth of 4.7 m as can be seen from the plot of Maximum principal stress (MPa) vs Distance from top of slab (m) (Figure 8) and the plot of Direct stress (MPa) vs Distance from top of slab (m)

(Figure 9). Positive values represent tensile stresses whereas negative values represent compressive stresses. The stress contour shows that almost whole of the top portion of concrete slab is under tension. Therefore, reinforcement is required only in the top portion of concrete slab.
