Water Hazard Characteristics of Dabaoshan Atypical Karst Tunnel

Liu Shao-Ming, Chen An, Liu Hao, Luo Sha-Sha. Water Hazard Characteristics of Dabaoshan Atypical Karst Tunnel. *American Journal of Civil Engineering*. Vol. 7, No. 2, 2019, pp. 59-63. doi: 10.11648/j.ajce.20190702.14

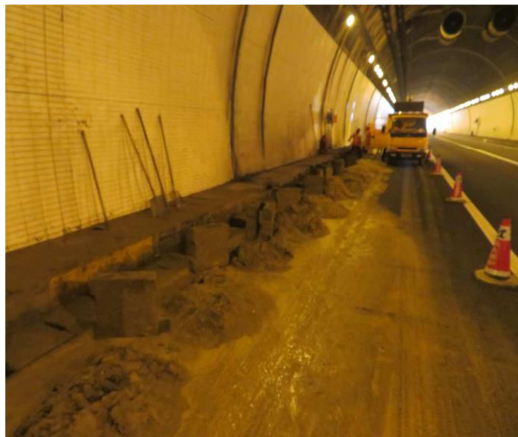
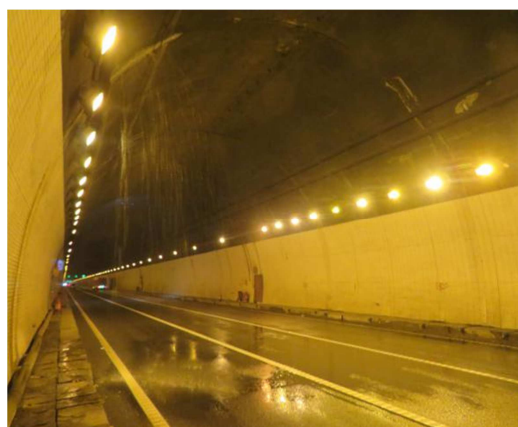
Figure 1. Gushing water and gushing mud in karst tunnel.

Kong-Macau expressway is located on the boundary of Qujiang and Wengyuan County, Shaoguan County, Guangdong Province, China. The entrance mileage of northbound line (left line) is NK1983+533, and the exit mileage is NK1985+118, which length is 1585m. The entrance mileage of southbound line (right line) is SK1983+553, and the exit mileage is SK1985+118, which length is 1565 m. On May 10, 2018, the torrential rain fell in Shaoguan, and there was gushing water and mud at the mileage of NK1984+840 in Dabaoshan atypical karst tunnel. Serious water leakage occurred in other areas, which directly threatened the traffic safety (Figure 1).

In May 2018, heavy rain fell in Shaoguan area, the groundwater level rose rapidly. As a result, there was gushing water and mud at the mileage of NK1984+840 in Dabaoshan tunnel, and severe water seepage and water leakage occurred in other areas (Figure 1), which seriously threatened the traffic safety.

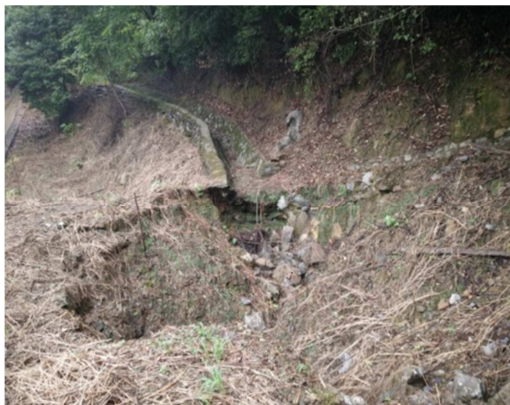
It is located at NK1984+836 above the tunnel (about 282m from the exit), which near the exit of Dabaoshan tunnel of 106 National Road. It's shape is nearly rectangular. The length is 7.7m, the breadth is 6.5m, and the height is 2.5m (Figure 2).

Figure 2. Karst collapse 1 (TX1).

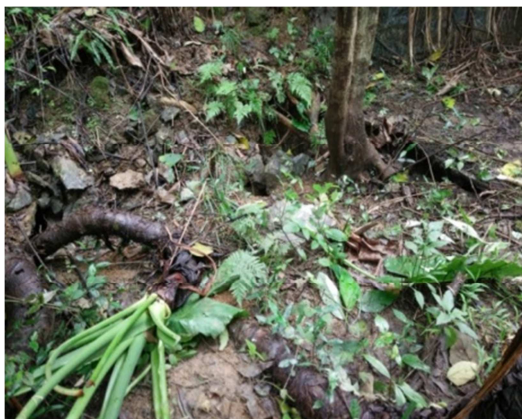
It is the old karst collapse, which surface has carried out hardening treatment. It is located at NK1983+933 above the tunnel (about 400m from the entrance). It's shape is nearly rectangular. The length is 5.5m, the breadth is 2.5m, and the height is 0.5-0.8m (Figure 3).

Figure 3. Karst collapse 2 (TX2).

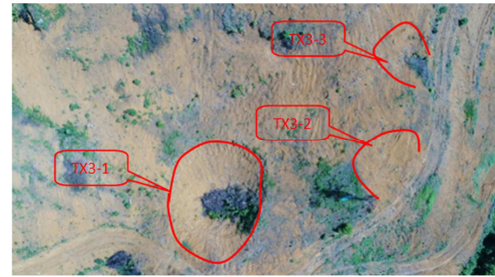
It is located at NK1983+610 above the tunnel. There are three collapses in this section (Figure 4).

The shape of collapse 3-1 (TX3-1) is nearly circular. Its radius is 35.0-40.0m and its depth is about 15m. The shape of collapse 3-2 (TX3-2) is nearly oval, its long axis is 30m and short axis is 20m, its depth is about 15m. The shape of collapse 3-3 (TX3-3) is nearly oval, its long axis is 20m and short axis is 15m, its depth is about 5m.

It is speculated that there are caves, solution fissure and fissure under the karst collapses.

Figure 4. Karst collapse 3 on the surface of hill (TX3).

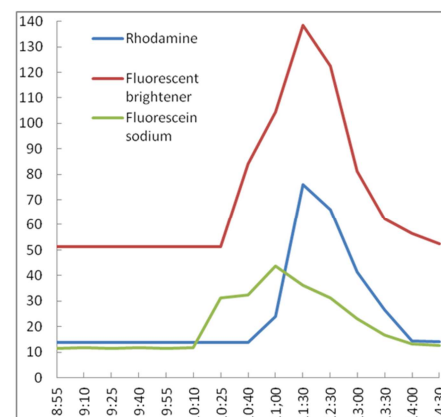
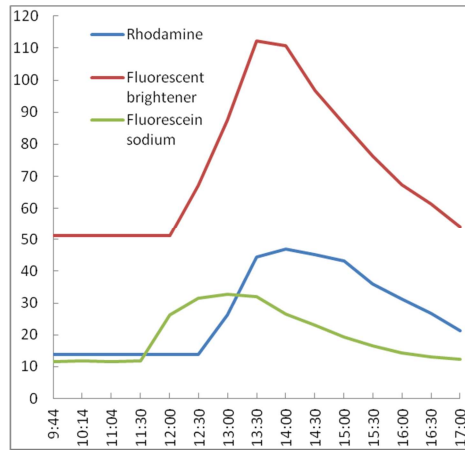
The groundwater receiving points: (1) left line slow lane exit drain, (2) left line passing lane exit drain. The results of groundwater connection test show that the karst collapse on the surface of the hill is connected to the tunnel (Figure 5).

Figure 5. Groundwater connection test results (June 21, 2018).

Limestone karst developed well. There are karst collapses on hill surface (figure 2, figure 3, figure 4). The three connectivity test results show that their concentration curves are very similar. They are single peak curves (figure 5). The times of peak values are two hours and it is indicate that rainfall smoothly flow into the tunnel. So the gushing water channels are karst collapses, karst caves, solution fissure and fissure.

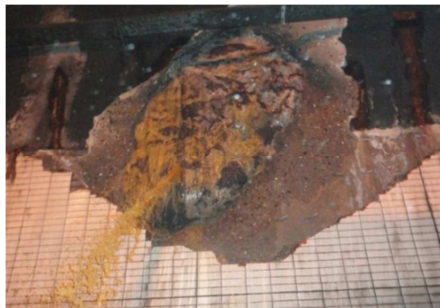
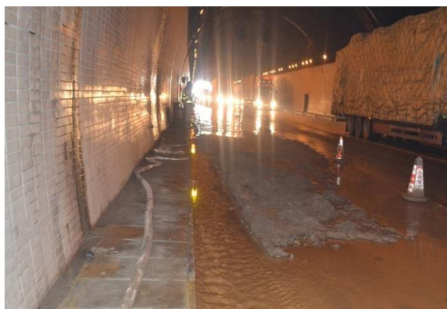
In May 2013, the heavy rains fell in Shaoguan area. The groundwater level increased rapidly, and the groundwater pressure on the tunnel lining increased sharply, which caused the emergence of the second lining concrete of the mileage of NK1983+978 in Dabaoshan tunnel (Figure 6).

Figure 6. Lining off and gushing water in tunnel.
