Characteristics and Causes of Water Seepage on Riverside Tunnel Structure and Control Measures in Sandy Pebble Stratus

Zhang Wenhan, Xu Jianxiao. Characteristics and Causes of Water Seepage on Riverside Tunnel Structure and Control Measures in Sandy Pebble Stratus. *American Journal of Civil Engineering*. Vol. 7, No. 4, 2019, pp. 101-107. doi: 10.11648/j.ajce.20190704.13

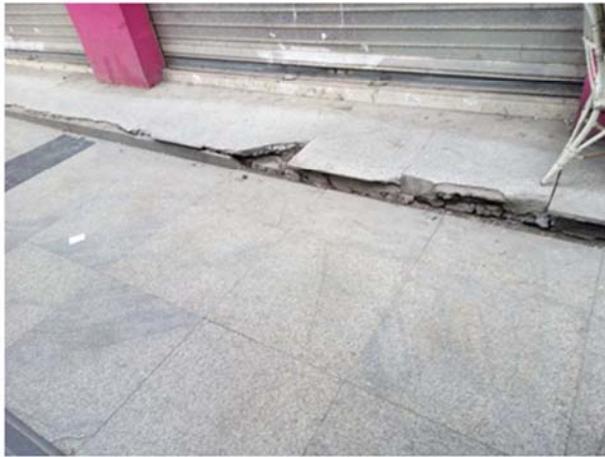
The whole underground tunnel seepage phenomenon is serious, large-scale water and sand gushing mainly concentrated in the original structure deformation joints and construction joints, underground passage water and sand accumulation phenomenon is serious, field investigation found a total of 1828 seepage points. At the same time, the continuous scouring of water takes away the sediment in the surrounding soil of underground engineering, destroys the original structure of surrounding roads and buildings, and even causes surface settlement and deformation. Voids have appeared in many areas. Field deformation diseases are shown in Figure 1.

(a) Surface subsidence and crack

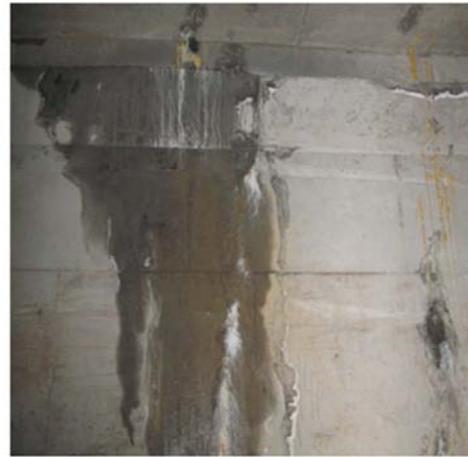
(b) Seepage of sidewall

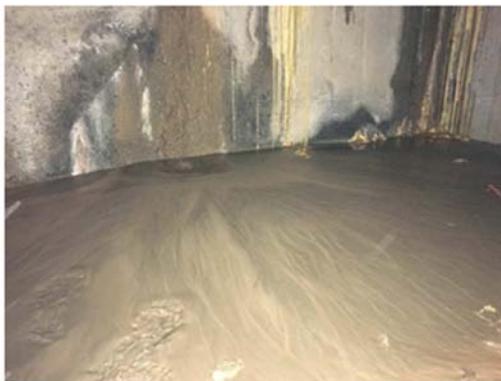
(c) Sand gushing from floor

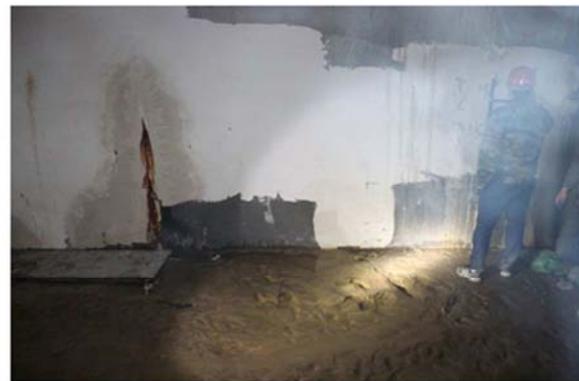
(d) Structural decoration layer seriously damaged

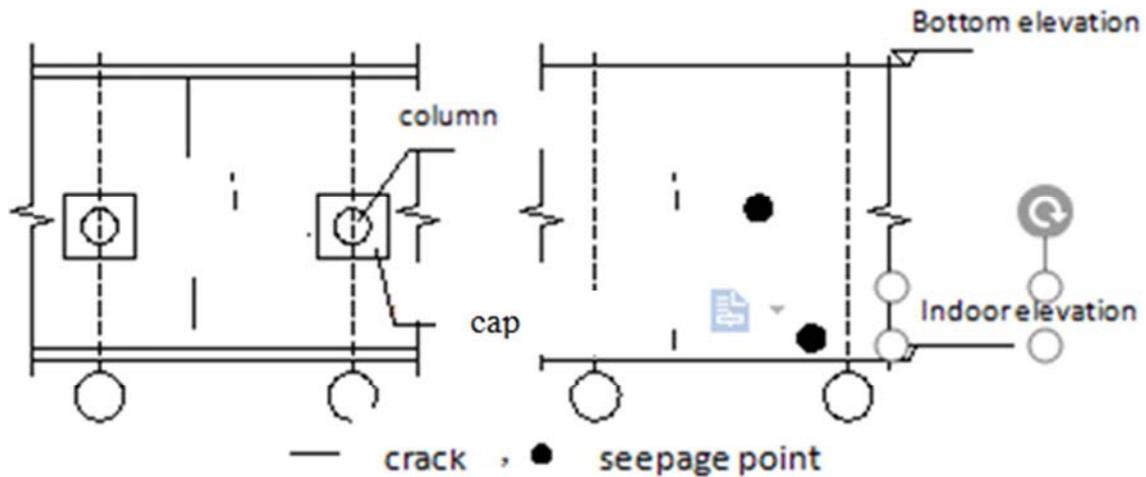
According to the field investigation, the crack development of concrete wall and roof conforms to certain rules. The wall surface is a point-like seepage point, vertical and horizontal seepage zone; the plate surface is mainly a band-like seepage

crack, which is characterized by developing along the transverse axis, long length and terminating at the column cap (or column bracket) or corner, reflecting the significant characteristics of longitudinal tensile stress; a few cracks are developed along the longitudinal axis and have a shorter length, and the roof and wall surface are classical. Figure 2 shows the distribution of cracks.

Figure 2. Diagram of typical crack distribution in concrete roof and wall.

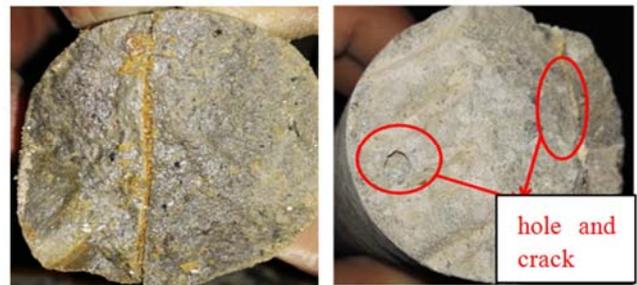
At the same time, according to the data, the waterproofing measures of the project are imperfect, and the inspection results of drilling holes in the side wall show that there are many structural joints and honeycomb holes in the structure. These structural weaknesses are the positions where groundwater is easy to pass through. The weak links provide a channel for groundwater seepage, as shown in Figure 3.

Figure 3. Concrete cracks and holes revealed by sidewall borehole.

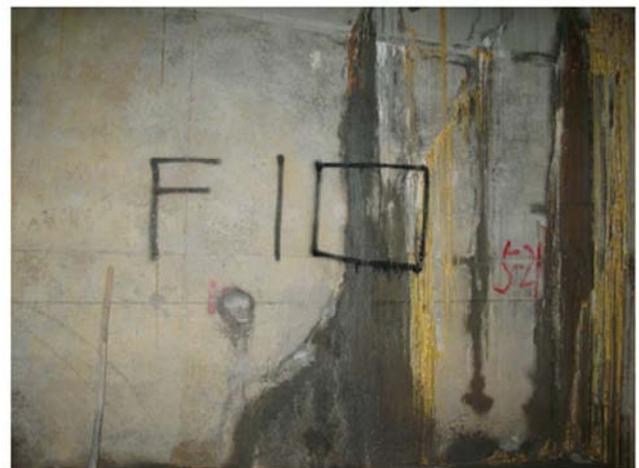
Later grouting treatment is mainly aimed at seepage or serious sand gushing. Side wall water gushing is columnar with a diameter of about 3 cm. At the same time, the water quality is turbid and contains silt. This treatment method has successfully stopped water and blocked sand gushing without

recurrence. As shown in Figure 5, it proves that the grouting treatment measures under the hydrogeological conditions of this project are effective.

Figure 6. Effect of sand gushing treatment.
