# The Major Causes of Flexible Pavement Deterioration and Propose Its Remedial Measures: A Case Study Bako to Gedo Road, Oromia Region, Ethiopia

**Shiferaw Garoma Wayessa, Dessalegn Geleta Abuye**

**Abstract:** Flexible pavement roads in Ethiopia often deteriorate in different ways, because of the harsh climatic conditions, lack of proper design and quality control, sudden increasing of traffic due to the construction of different industries, high loads and inadequate assessment for identifying causes of deteriorate before carrying out Maintenance and Rehabilitation. A possible remedial measures had been organized for every observed failure or deterioration to obtain normal pavement condition of the study area. An investigation was made by using laboratory and field test to determine the adequacy of the underlain material to serve as a subgrade, sub base course and base course for road construction based on project specifications and Ethiopian Road Authority (ERA) Specification. The investigation covered field tests to determine the in-situ condition of the road materials while laboratory tests on representative samples were extracted from site to determine the engineering proper

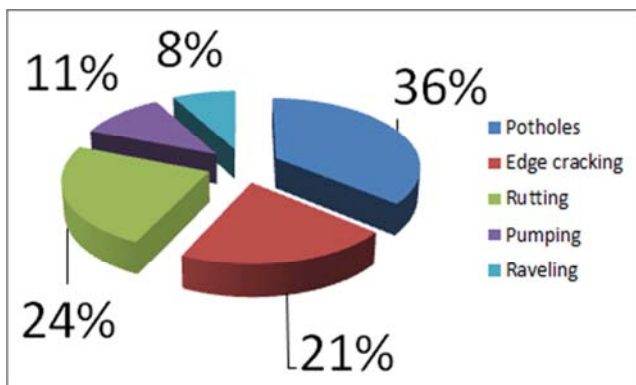
Figure 1. The percentage of common deterioration types and their severity.

The major types of deterioration observed along the study area of Bako-Gedo rehabilitation Road Project. Relative to this, the researcher had organized the possible deterioration types based on existing condition of the pavement surface together with the extent of damage and had been ranked accordingly. The following Figures show the different photos taken from the field observation of the different types of deterioration along Bako-Gedo road project.

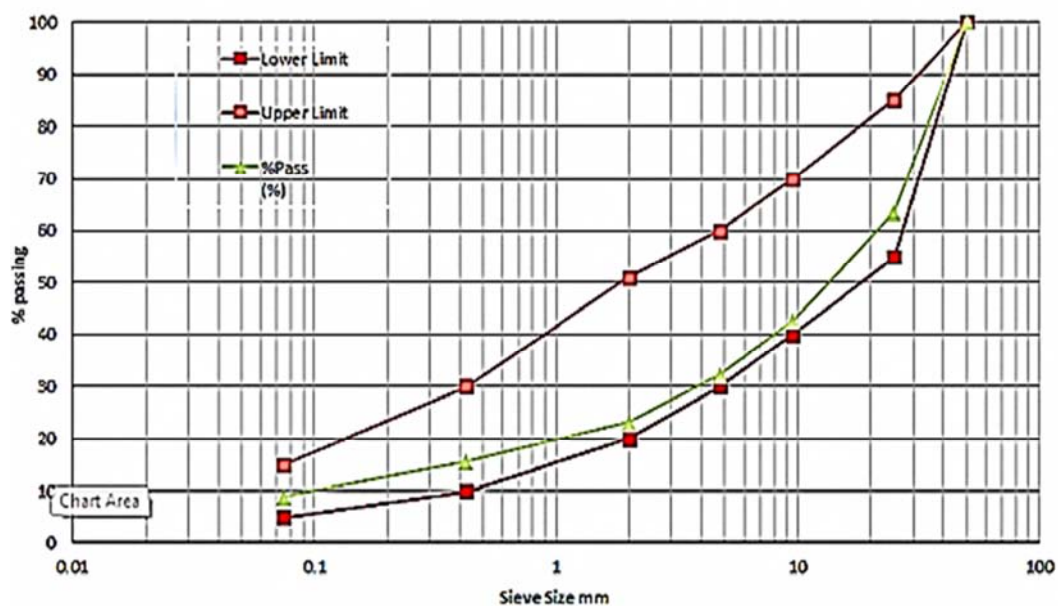
It can be observed that the gradation of the base course at all the three sections, the gradation is within the recommended range. However, this recommended range will come to invalid if there is a possibility of moisture fluctuation because of poor drainage condition. Since this moisture fluctuation can be affected or washed out the fine ingredients of the base course

Figure 10. Comparison of base course material at section (1) with GB1.

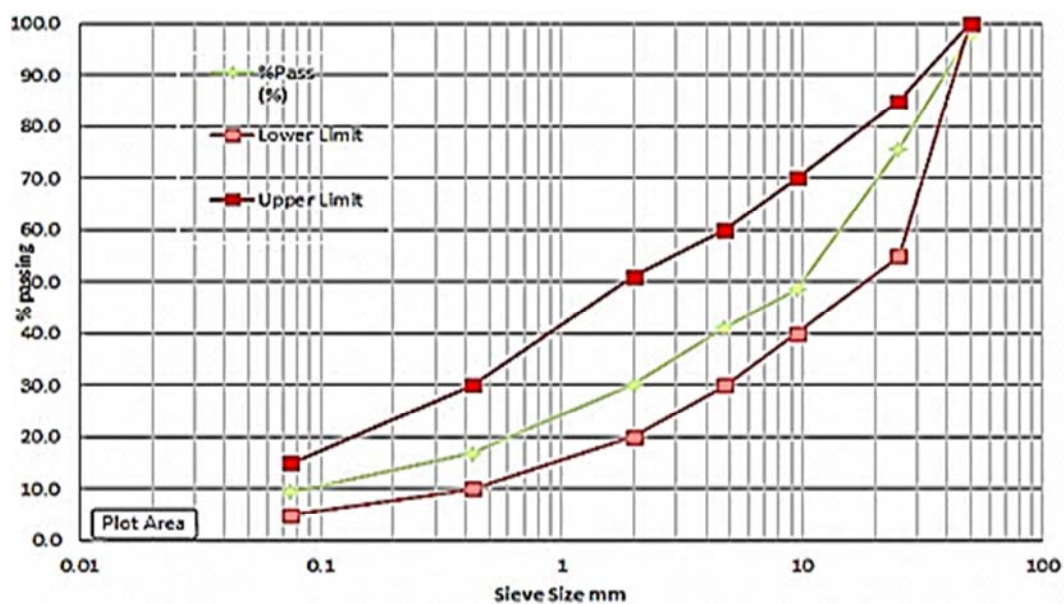
Figure 11. Comparison of base course material at section (2) with GB1.

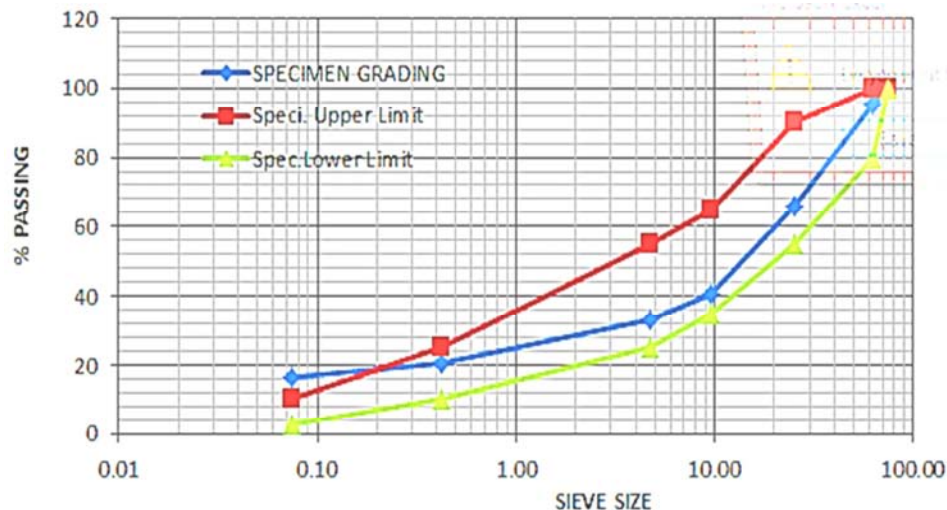
Figure 12. Comparison of base course material at section (3) with GB1.

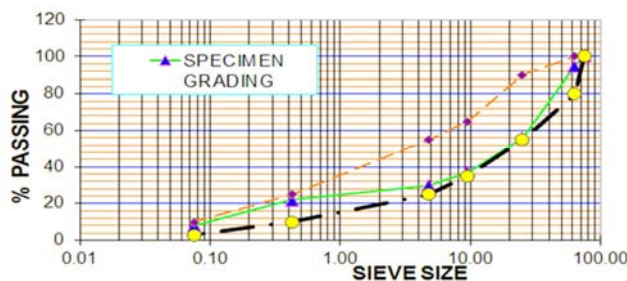
From above figures, be observed that the gradation of the natural sub base at all the three sections. Gradation analysis was made for this layer at all sections and have different gradation curve with the section. However, it could be noted that section (1) and (2) lie within the recommended range

Based on, the gradation curve, it can be summarized that, the materials used at section (1) and (2) are relatively stable enough and have a good resistant to erosion. This can be compacted to a very dense condition which produce and develop good bearing capacity and shearing resistance. However, at section (3) the material used was course which is not having a good resistant to erosion stable enough.

Figure 13. Comparison of natural sub base course material at section (1) with GS2.

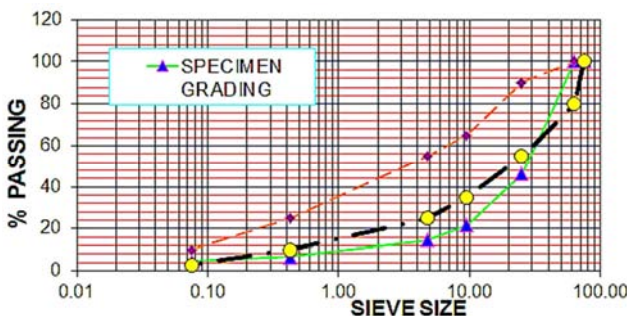
Figure 14. Comparison of natural sub base course material at section (2) with GS2.
