Alkali-Aggregate Reaction: Definition, Influence and Control

Abstract: The alkali-aggregate reaction is a pathological manifestation due from chemical processes of interaction of reactive minerals that are present in some aggregates, and alkali hydroxides from Portland cement, water kneading and external agents dissolved in the solution present in the pores of concrete. It is a reaction that occurs slowly, but may cause irreparable damage, for example with cracks that impair the mechanical strength and durability of the affected structure. The main objective of this work is to expand the existing knowledge about the evolution of this pathological manifestation in order to contribute to eradicate this problem in the construction works. The methodology used in the article includes a literature review that addresses a history of occurrence of alkali-aggregate reaction in Brazil and around the world, its definition, the types of reaction, the factors that influence it, control methods and some cases in Metropolitan region of Recife that had this pathological manifestation during the construction process and during its lifetime. The article here presented is intended to contribute to s

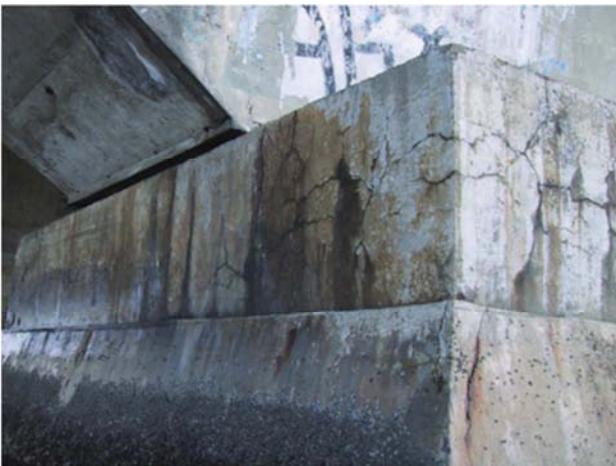
According to a case study carried out, all the support blocks of the main beams of the bridge presented pathologies worthy of attention, mainly cracks. The fissure frame varied from block to block, usually in "spider web" or "map" format, some with large openings.

The fissures were predominantly in the blocks themselves, but they could also be seen in the calyxes and the pre-welded plates that cover the calyxes and their bases (Figure 2). This framework of cracking in concrete pieces is characteristic of the occurrence of alkali-aggregate [25].

Figure 2. Signs of AAR in the central span support block of the Paulo Guerra Bridge [26].

Due to the local conditions and the advanced deterioration, the solution adopted for the recovery of the bridge was a structural project that chose to take advantage of the existing blocks, recovering them and reinforcing them through an encapsulation in reinforced concrete. This seemed to be the best alternative. As it is not possible to keep the concrete away from the water, it is expected that the AAR will continue in the foundation block. The designed confinement needed to withstand the forces of reaction expansion. For this purpose, it was decided to use a confinement force capable of withstanding tensile stresses of the order of 4 MPa (580 psi) [26].

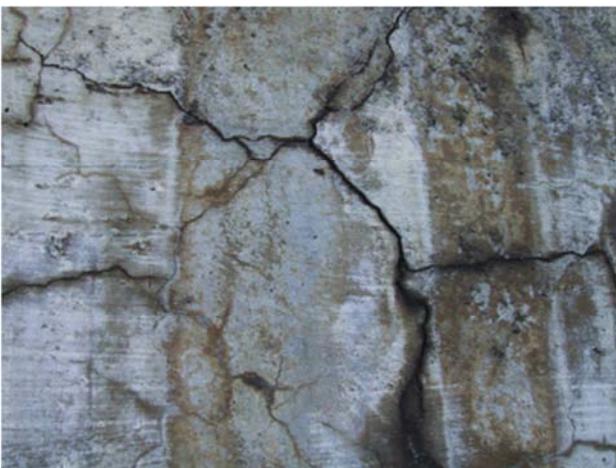
Figure 3. Crack in the shape of a map in the foundation block of the Paulo Guerra Bridge [26].

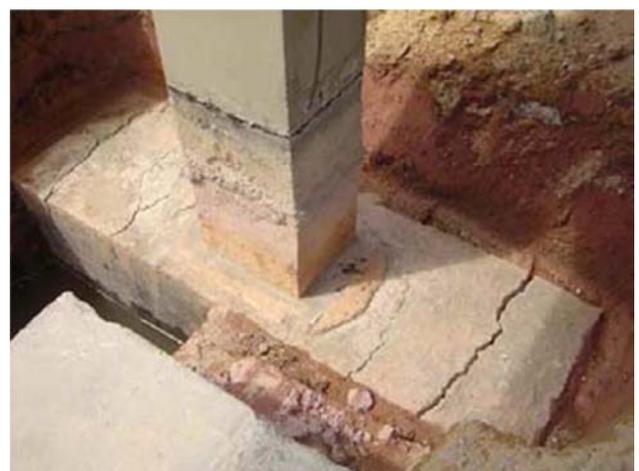
Figure 4. Fissure in block on two stakes, with dimensions 1 x 2,5m [25].

In the analyzes it was observed that in some cases, besides the vertical cracks in the blocks on two stakes have exceeded the connecting rods, in two cases, at the bottom of the building, the AAR weakened the blocks to such an extent that there were redistribution of loads to other blocks.

The company responsible for the recovery was JLC Project Engineering Ltda., from Rio de Janeiro and with the table presented, a mechanism was necessary to recompose the section of the block, introducing compression stresses in the block, through pretension (being in the larger blocks made in two directions), using Dywidag bars. In addition, it was necessary to seal the block to prevent the subsoil water from reaching the block by capillarity, thus re-feeding the alkali-aggregate reaction process.

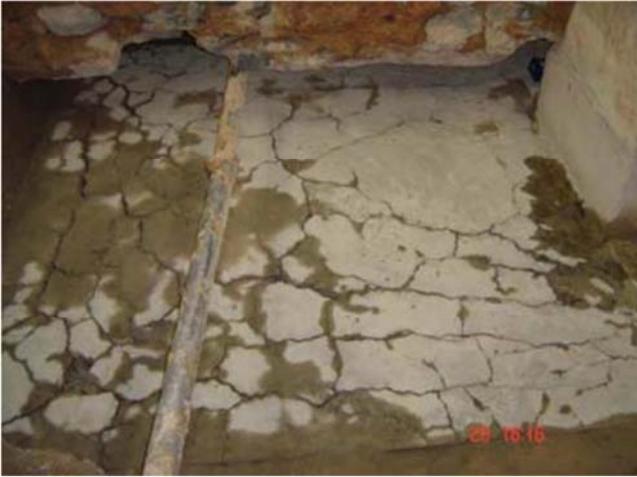
Figure 5. Block fissure with 18 stakes, with dimensions 8 x 6m [25].

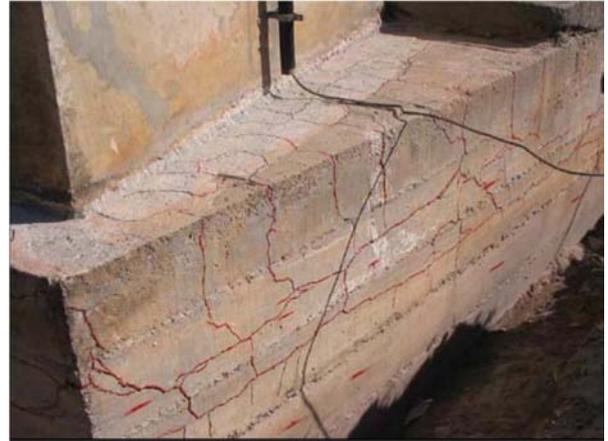
The foundation blocks presented a picture of cracks, with the largest blocks of the building (stakes 8 and 9), the blocks with more intense and variable cracks, while the secondary blocks (stake 1) were intact. Figures 5 and 6 show the cracks painted in color and the largest crack found in the work, respectively [25].

Figure 6. Upper and lateral block faces with cracks painted [25].

With the confirmation of the occurrence of the AAR in the foundation blocks, the structural recovery actions were defined. The solution adopted was concentrated in two steps - the closing of the cracks and the intensification of the reinforcement. The closure of fissures and cracks with appropriate material had the main objective of protecting the blocks against the possible entry of deleterious product and humidity, factors that aggravate the alkali-aggregate reaction. The recovery of the blocks aimed at reconstituting the rigidity of the same and intensificate the reinforcement that combats the tensile stresses and in order to promote the sealing of the same ones with waterproofing material, to inhibit the continuation of the AAR process [25].

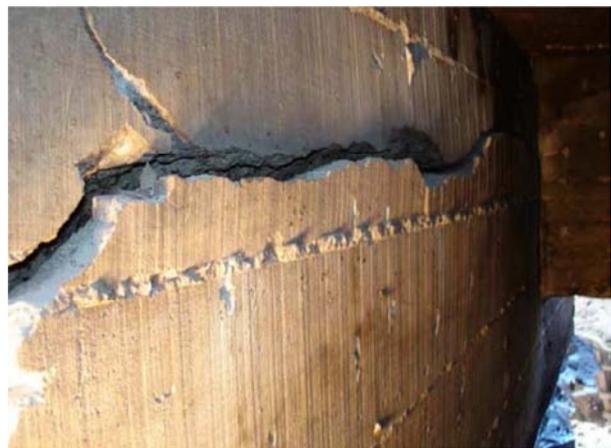
Figure 7. Horizontal crack with large opening and displacement [25].

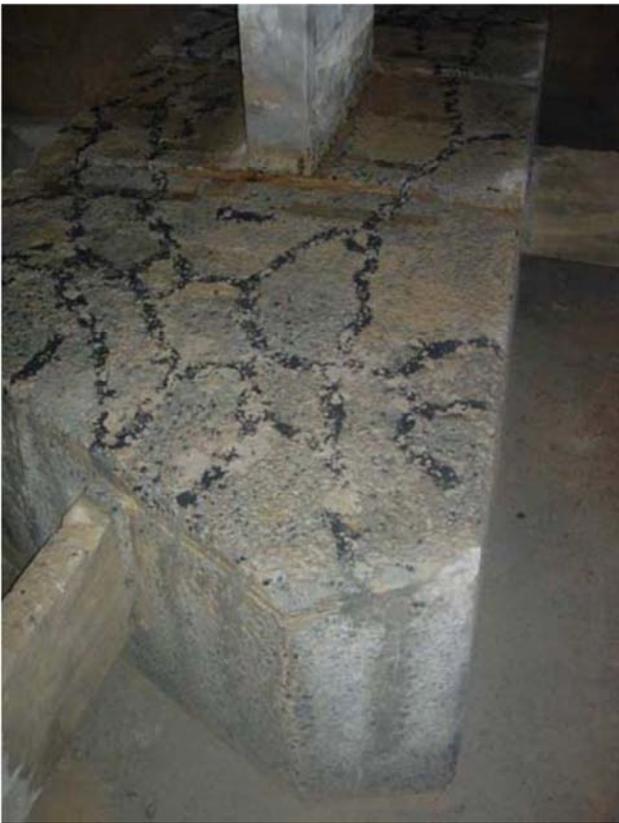
that in the year 1983, three years after its construction, the work had already presented fissures in some blocks, being reinforced the ones. However in 2008 it was found that some blocks which had not been reinforced in 1983, now presented many fissures in the lateral and upper faces, with similar aspect to those of several buildings in which the existence of AAR was already established in the metropolitan area of Recife. Figure 7 shows the cracks in the foundation block already filled with microcement [25].

Figure 8. Foundation block with cracks already filled [25].

Confirming the existence of AAR in the blocks and considering the advanced age of the building - 30 years, it was suggested that most of the expansion of the reaction had already occurred. Thus, it was recommended to solve the problem the filling of the fissure with microcement and subsequent encapsulation of the block with concrete layer in the lateral and upper faces, being recommended concrete with $f_{ck} \geq 40$ MPa with metakaolin addition, in order to inhibit the incidence of AAR in the new concrete.

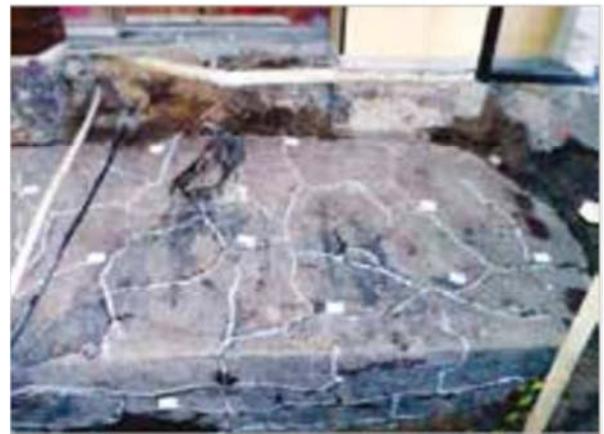
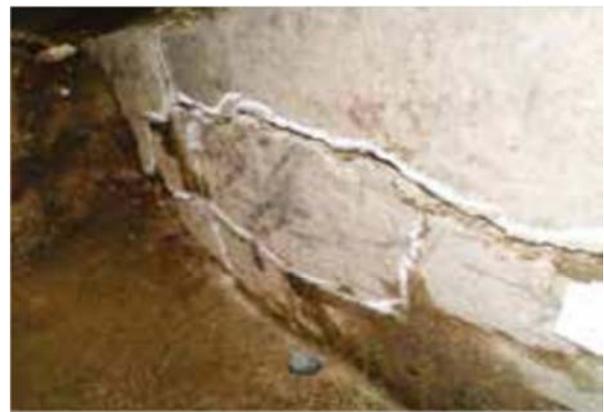
The construction of the building started in 1998 and ended in 2002. Fearful after the collapse of the Areia Branca building in 2004, the building's residents hired an inspection of the property in 2005, mainly due to the cracks found in the shoes. Although the appropriate tests for the diagnosis of the cracks had not been performed, the low shoes were recovered with the injection of rigid epoxy resin. In 2014, there was a new inspection to evaluate the state of the low shoes and it was verified that the ones inspected and recovered in the past have returned to many cracks and fissures (Figures 9 and 10). From this, the tests of resistance to compression of these shoes were made and, after studying the history of the foundation, the environmental factors and the characteristics of the building and in front of the realized tests, it was concluded that the foundation presented the picture of known pathological manifestation as an alkali-aggregate reaction [27].

Figure 9. Low shoes with cracks in maps marked with chalk [27].

The excavation was carried out around the shoes that were buried. After the faces of the shoes were excavated, the cleaning procedure was carried out with the washing of the structure, using a high pressure jet equipment for better visualization of the areas affected by cracks and fissures,

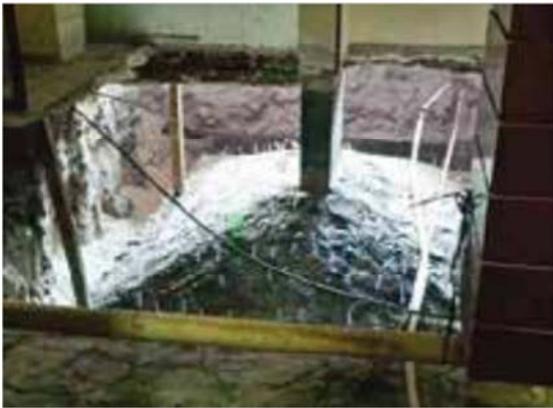
Figure 10. Low shoe bleeders [27].

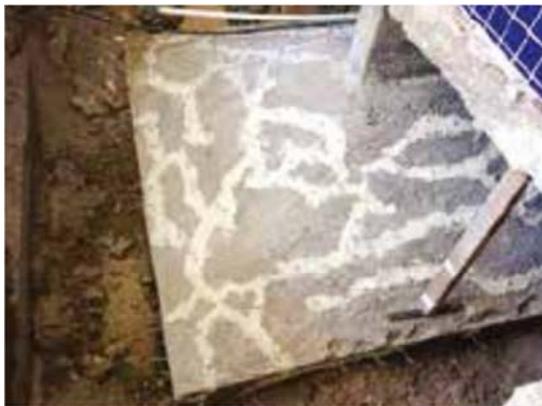
Figure 11. Cracks and fissures clogging [27].

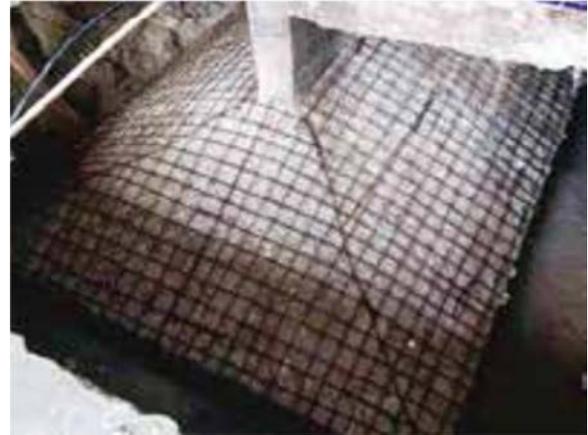
Figure 12. Steel mesh for shoe encapsulation [27].

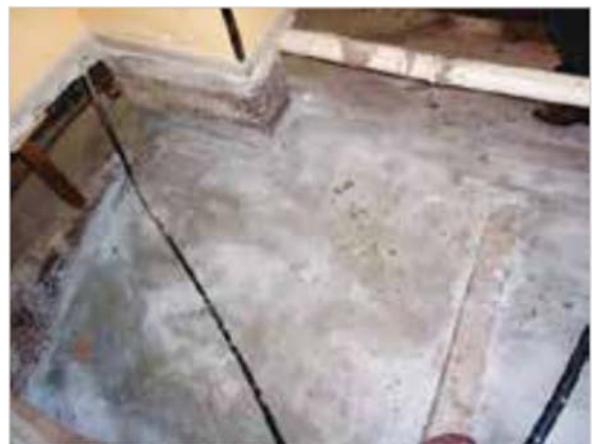
The recovery service was incomplete because, at the end of the shoe encapsulation, these were not waterproofed, which may facilitate the penetration of aggressive external agents and moisture. The method described in this work is the most widely used and known to the present moment for recovery of alkali-aggregate reaction, but it is not totally effective. The proof of this, is that some shoes that had already been recovered previously but, after a few years, returned to present the fissures [27].

Figure 13. Concreted shoe [27].
