# MP-1™ Polyimide for Medical Devices: 1. Pre Clinical Studies

**Abstract:** Due to constant increase in human life expectancy, more people require primary and revision total hip replacement surgeries, costing billions of US\$ per year. Currently used ceramic on X-linked Polyethylene appears to be the best choice by default, but it still wears. The wear particles generated, are the major cause of osteolysis and joint failure. During 2011-14, leading orthopedic companies suffered global recalls of their MoM hip systems resulting in thousands of revision surgeries. The search continues for new and more durable materials bearing materials. Developments in medical technology have increased the demand for advanced materials due to aging population, advanced medical procedures and contagious diseases. Metals and ceramics are prevalent in the medical industry. However, the unique properties of polymeric materials exhibit potential as better replacements for conventional materials. MMATECH Ltd. has developed a new articulation liner made of a revolutionary material of the Polyimide family, MP-1™, a spin-off of the Aerospace industry. MP-1™ has proved to be biocompatible, heat-resistant, h

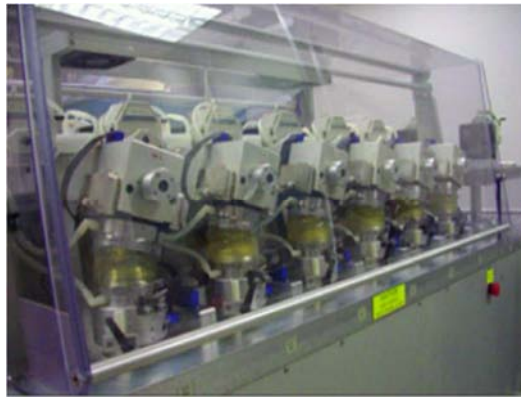
Figure 2. Hip simulator testing

The hip joint simulator performs 2x3 simultaneous tests (and two soaked controls) Figure 2. The specimens are oriented in an anatomically correct position; the resulting hip joint force was applied on the liner via the cup. Consequently, the direction of the force vector was constant relative to the cup and moved relative to the head. All three in-vivo angular displacements were simulated: Flexion / extension, abduction / adduction and internal / external rotation. The specimens were assembled under laminar flow conditions and sealed by capsulated single test chambers to exclude contamination. The temperature of the test fluid as well as the fluid level was controlled throughout the testing. The wear of the components was determined gravimetrically and calculated volumetrically.

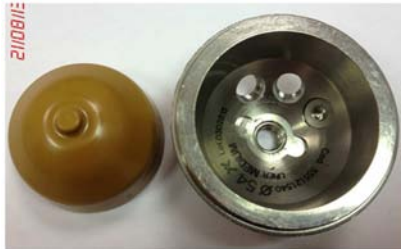
**Figure 3.** Cup and liner for testing.

23 liners were produced, according to CNC drawings, by compression molding of MP-1™ powder to blocks and machining the blocks to final liner shape (Figure 3). Every design of total hip arthroplasty system has usually three sizes; Small, Medium and Large (Table 1).

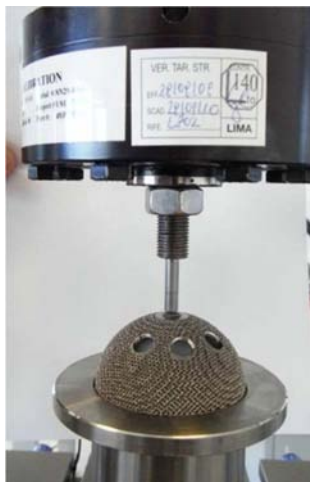
**Figure 4.** Push-out test.

**Figure 5.** Push-out test.

Modular Acetabular Device in push out test. Push Out Test six MP-1™ liners (MMATECH) were assembled into Delta TT shells featuring an 18-degree tapered internal geometry. Liners are pressed into the cup by means of a ceramic head at  $2000 \pm 50$  N maximum load (according to Ceramtec procedure). The whole system of cup and liner are subsequently put on a metallic ring which fully supports the cup but not the liner (Figures 4, 5).

The liner is pushed-out pressing on the polar protrusion with a 6 mm metallic plunge. The applied disassembly load is recorded by means of the load cell.

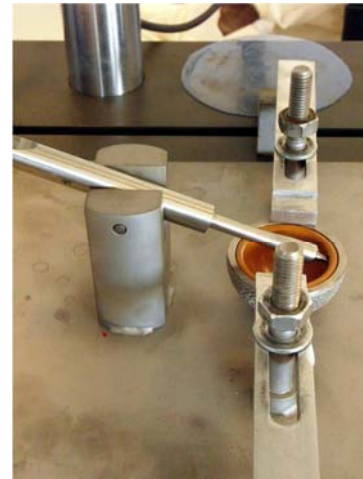
**Figure 6.** Lever-out test.

**Figure 7.** Lever-out test.

Lever out test is performed by disarticulating liner from cup by means of a lever arm (Figures 6, 7), lever is joined to MP-1™ liner by a hole in 5 mm diameter. The liner is pressed into the cup in with a force  $2000 \pm 50$  N.

The parameter considered to evaluate stability is the bending moment calculated by multiplication of applied force and the lever arm for the cosine of the inclination angle ( $\alpha$ ).

Force is applied till insert-cup disassembly. The lever bar is loaded at a rate of 5mm/ min. at the external side at 58,5 mm (b) from the fulcrum (Figure 6). The length of the lever arm from the fulcrum to its insertion point into the liner is 86,0 mm (a). The inclination angle ( $\alpha$ ) 25°. A force-displacement curve is recorded. The maximum lever out torque, (calculated by the maximum force multiplied by the lever arm length(b)) is presented as a further measure of the locking mechanism strength.

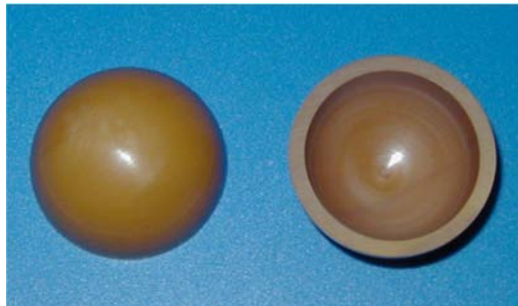
**Figure 9.** Test samples made of MP-1™ for impact test.

Six (6) MP-1™ samples were tested. Each sample was machined into hemispheres with a 38mm outer diameter and 2 mm thick (Figure 9). The parts were immersed in bovine serum, diluted 25% with buffer solution, to mimic the part's environment and friction conditions in the body.

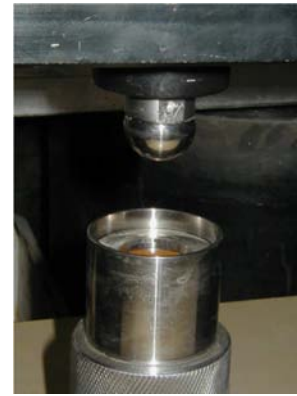
**Figure 10.** Impact test machine.

The parts were placed in the concave station of the loading machine with the apex of the shell oriented downward (Figure 10). The Bovine Serum was poured into the test article such that the serum reached the top mark on the station's metal cup.

A pneumatically driven mechanism pressed a metal head against the test article in a vertical axis. The diameter of the metal head was 1 mm smaller than the internal diameter of the test article, causing a 0.5 mm clearance, which represents a typical clinical clearance scenario.
