Analysis of Vegetation Effects on Slope Stability of Embankment

Md. Murad Hasan, Mehejabin Chowdhury Ankan. Analysis of Vegetation Effects on Slope Stability of Embankment. *American Journal of Civil Engineering*. Vol. 8, No. 4, 2020, pp. 77-86. doi: 10.11648/j.ajce.20200804.11

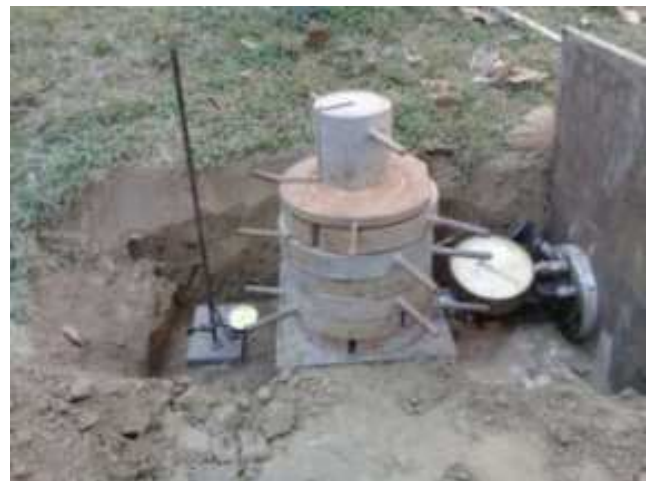
Figure 3. Experimental setup of in-situ direct shear test.

An experimental setup was developed in this study to determine the in-situ shear strength of soil profile vegetated with tree root and without root. The shear box was made of 6 mm thick steel plates (0.30 m x 0.30 m x 0.10 m) capable of holding firmly a soil block of 0.30 m x 0.30m x 0.15 m in dimensions. A hydraulic jack with load gauge having

capacity of 5 tons was used to apply shear force and a Linear Variable Displacement Transducer (LVDT) was used to determine the horizontal displacement while applying the shear forces. The applied shear forces were read directly from the load gauge that was set with the hydraulic jack. The detail experimental setup has been shown in the figure 3.

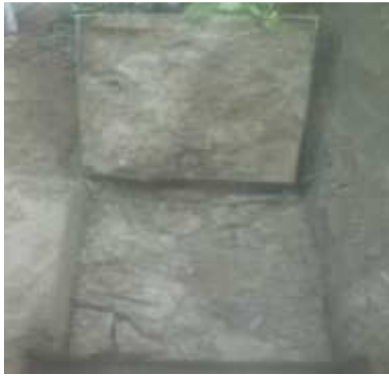
Figure 4. Failure plane of soil block without root.

experimental setup and isolate the soil block from the surrounding soil. The shearing force was applied by hydraulic jack that acted on steel plate of the shear box. The hydraulic force was applied by operating a lever arm and enough space was provided on the opposite side of the hydraulic jack of the shear box for the shear displacement. The shear force was obtained from the load gauge attached to the hydraulic jack and the shear displacement was measured using the dial gauge. Block samples were tested at 0.15m depth under different normal stresses at the field to know the in-situ shear strength of the rooted soil and soil without root following this procedure. The test was performed at 0.15 m depth of each two trenches (i.e., soil block with root and without root) applying the same normal load to determine the increase in shear strength of soil specimen due to penetration of tree root for the same normal load. After shearing the soil block to fail, the shear surface and the orientation of the failed roots were examined carefully to estimate the shear distortion during failure. A total of 9 block samples were tested in the field under different normal stress (i.e., 6.18 kPa, 8.73 kPa and 10.89 kPa) at 0.15 m depth from the existing ground level excavating 9 trenches. Out of 9 samples 6 samples were rooted soil (3 samples for lebbek tree and 3 samples for royal poinciana) and 3 samples were soil without root. Figure 4 and Figure 5 shows the failure plane of soil block without root and with root respectively.

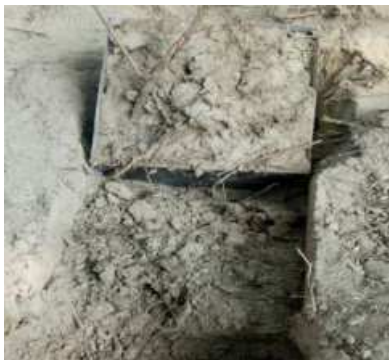
Figure 5. Failure plane of soil block with root.
