# Effect of Pollution on Mechanical Properties of Foundations in Towers of Electrical Transmission

**Abstract:** The effect of meteorological variables such as relative humidity, maximum temperature, and predominant wind orientation, as well as oxidant species on the variation of mechanical resistance to compression of the cylinders extracted from two electric transmission towers was investigated. The obtained results are compared with the mechanical strength to compression achieved in concrete cylinders prepared in the laboratory and submerged in solutions of nitric acid and sulfuric acid in concentrations taken from the statistical data of nitrous oxide and sulfurous present in the environment where have installed the towers under study. The results show a decrease in the mechanical strength of the exposed cores in the predominant direction of the wind and of the cylinders submerged in the solution with acids, concluding that both conditions favor the degradation of concrete properties.

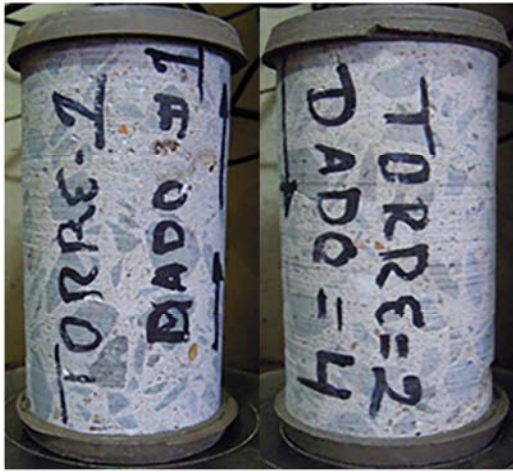
Of two electrical transmission towers, eight cylindrical concrete cores were obtained from the foundation. These are known as cores and are extracted by drilling the concrete mass with a thin-walled cylindrical drill [6], the diameter of these are approximately 7.5 cm by 15 cm in length, images of two cores are presented in Figure 1.

**Figure 1.** Cores extracted from two electric transmission towers.

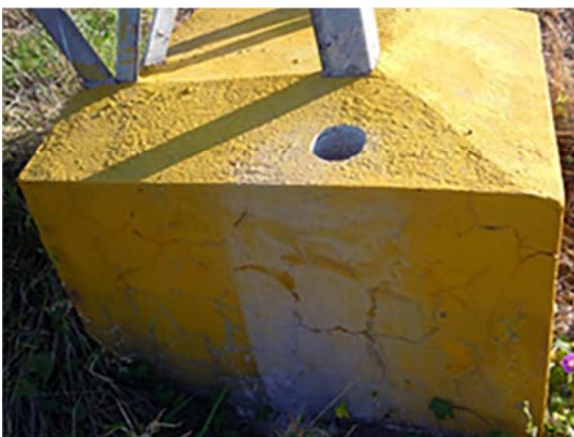
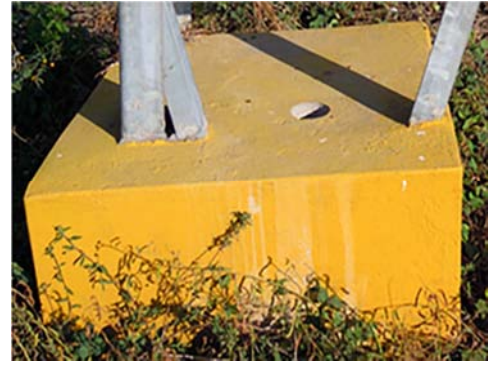
This type of sample is obtained when there is doubt about the quality of the concrete in place, either because of a low value of resistance achieved during the construction or by signs of structural damage. However, one more use is to provide information about resistance in older structures [42]. The study samples were identified as T1C1, T2C1, etc., where T1 and T2 represent the tower number from which they were extracted, C is the core, and the final number corresponds to the foundation of each leg of the reference tower, four for each one, Figure 2.

**Figure 2.** Core extraction foundations: (a) T1C1, (b) T2C3.

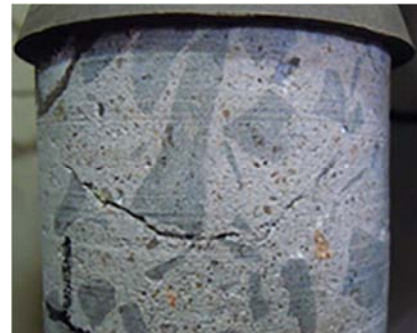
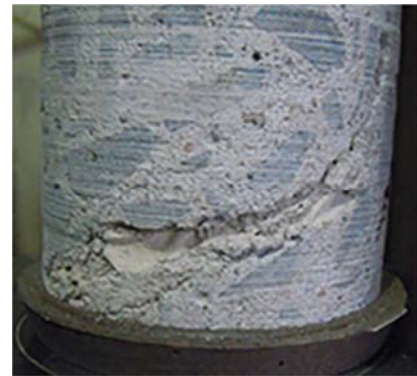
The samples T1C1 and T2C4 had defects, which can be seen in Figure 3.

**Figure 3.** Core defects: a) T1C1 and (b) T2C4.

The defect present in the core T2C4 affected the value of mechanical compressive strength and the trend of the fracture in this sample.

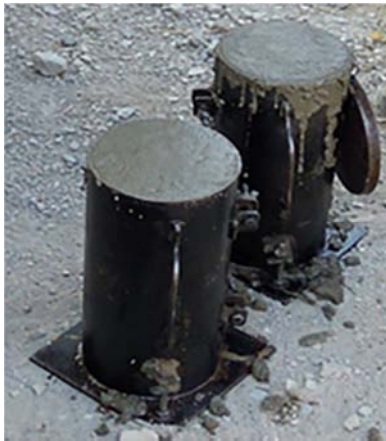
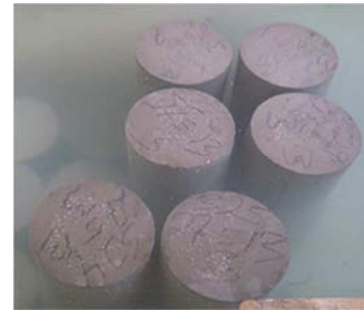
In addition to the cores, 7 cylindrical samples measuring 15 cm in diameter by 30 cm in height were prepared with a design strength of 200 kg/cm<sup>2</sup>, following the specifications for foundations of electrical transmission towers dictated by the regulatory body in Mexico, Commission Federal Electricity CFE. The samples were demolding 24 hours after the casting and 28 days were maintained in a curing room at 100% relative humidity with the controlled temperature between 20°C and 25°C, these conditions are considered as conventional curing, Figure 4.

**Figure 4.** Molded cylindrical samples.

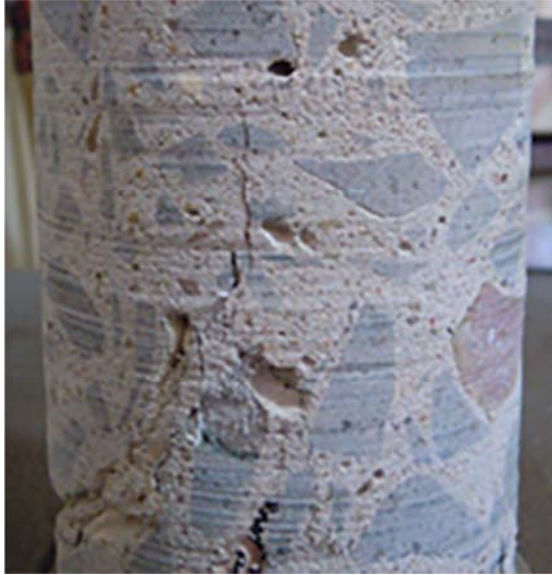
formation during cement hydration due to the pozzolanic reaction can improve concrete properties such as strength and durability. The cement—pozzolan—water mixture is a complex system, consisting of many physicochemical processes that are influenced by temperature, mixing proportion, pozzolan reactivity, pozzolan particle size and other factors. The water in pores can also fracture the concrete by alternate freezing and thawing, thereby enhancing further water penetration. So the sample T2C4 presents a low resistance value compared to the other cores, in this sample, the fracture initiation was present before the

test Figure 5. When the test was applied, the fracture followed the path of the defect. It is important to mention that cores are subject to variable ambient conditions in service and varying conditions after extraction. Cores are tested in the dry or wet condition, rarely in the saturated condition as the cylinders cured in the laboratory [12].

Figure 5. The drift of T2C4 heart fracture.

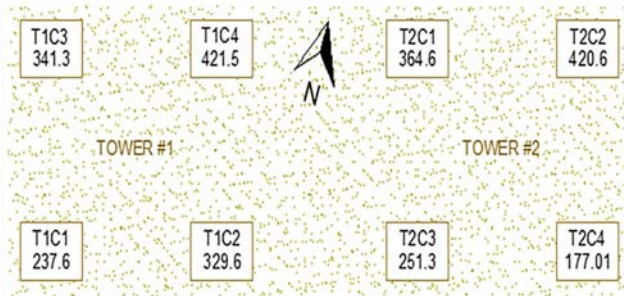
The diagram of Figure 6 shows the arrangement of the foundations of the transmission towers, including the nomenclature of the extracted core and its corresponding value of the results of mechanical resistance to compression obtained from the tests in  $\text{kg/cm}^2$ .

Figure 6. Distribution of foundations in transmission towers.

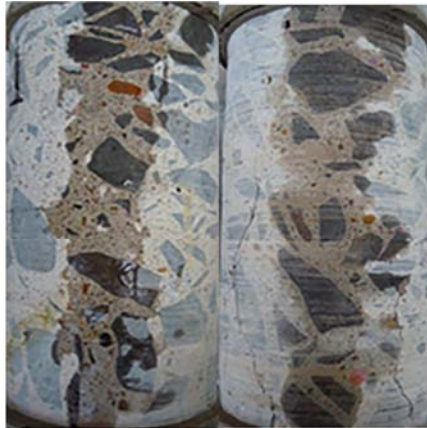
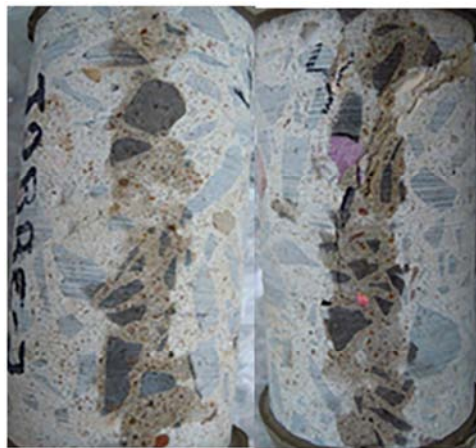
Where pH is experimentally measured, and pH<sub>s</sub> is the pH value at which the water is in equilibrium with solid calcium carbonate. A positive SI indicates sufficient alkalinity and calcium carbonate will precipitate. The solution of phenolphthalein poured in the extracted cores, present a very marked purple coloration, as it shows Figure 7, which indicates carbonation present in the cores.

**Figure 7.** Test of phenolphthalein in tower number two hearts.

The application of phenolphthalein reveals damage in concrete and allows to distinguish between carbonation and damage by the presence of polluting species in the environment.

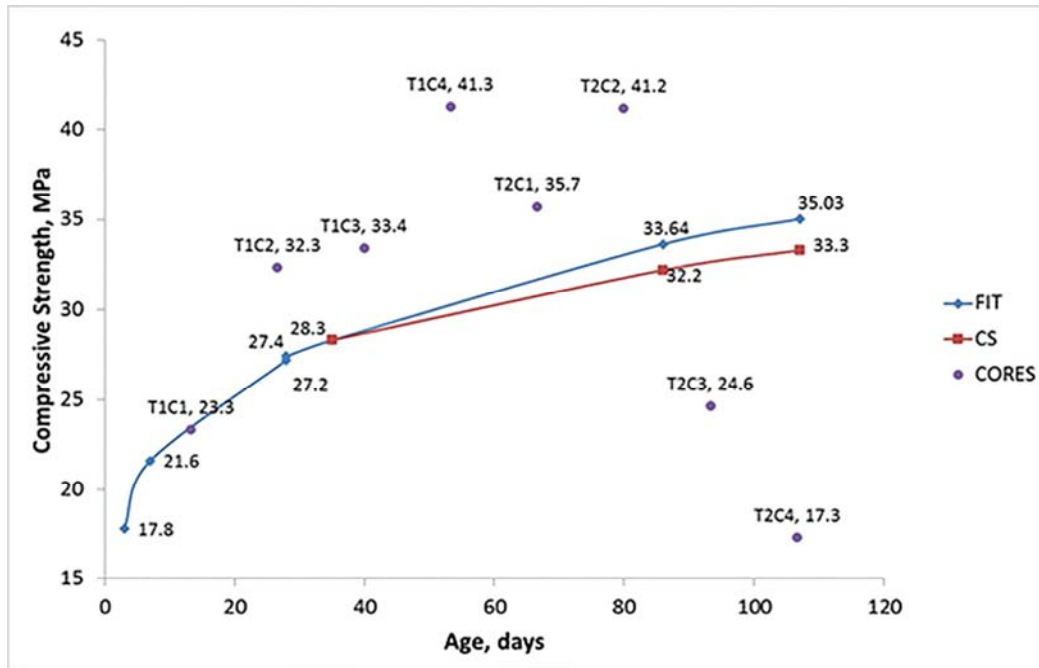
The results of the investigation show the increase of the compressive strength under normal curing conditions in samples CS1, CS2, CS3, CS4, and CS5. However, the resistance of CS6 and CS7 samples is affected when the acids solutions are applied. As the hydration continues, the concrete becomes harder and stronger, which occurs over the first month, but if there are adequate humidity and temperature, this continues more slowly for a more extended period, which exceeds thirty years in which a continuous increase in resistance has been reported. The increase in strength with age continues as long as the no hydrated cement is still present, the concrete remains wet, or the relative humidity of the air is above about 80%, and the temperature of the concrete remains favorable [12]. In Figure 8 the exponential adjustment of the tendency to increase the compressive strength is presented in blue, considering the results of samples CS1, CS2, CS3, and CS4; while in red the values obtained from samples CS5, CS6 and CS7 are presented. The dots in purple indicate the compressive strength value for each core obtained.

Figure 8. Compressive Strength – Time.

This graph shows that the value obtained in sample CS5, once moistened, falls in the trend line of resistance increase for normal curing conditions. However the values of the samples CS6 and CS7 are separated from this tendency, with which the presence of the acids causes the decrease of the value of mechanical resistance to compression. Also, the strength values of the cores in the prevailing wind direction are lower, concluding that these values are affected by the contamination conditions to which the transmission towers are exposed. It is important to mention that the actual age of the towers is ten years and that according to S. H. [12], higher values of resistance in the T1C1, T1C2, T1C3, T2C1, T2C3 and T2C4 cores would be expected.

The application of the nitric and sulfuric acids in the molded samples, affect the value of the mechanical compressive strength of these specimens.
