# Reason Analysis and Countermeasures of Coal-Fired Power Plant Denitrification Ammonia Injection Valve Blockage

Jiang Pengwei, Guo Yueyei, Ni Ye. Reason Analysis and Countermeasures of Coal-Fired Power Plant Denitrification Ammonia Injection Valve Blockage. *American Journal of Electrical Power and Energy Systems*. Vol. 7, No. 5, 2018, pp. 56-61. doi: 10.11648/j.epes.20180705.11

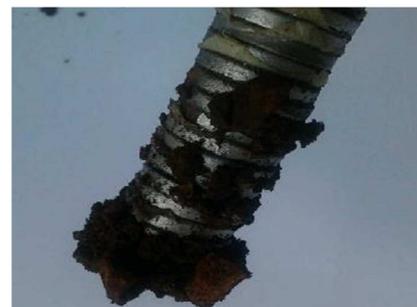
increase of operation time, jam frequency increased. After that, the SCR ammonia injection regulating valve of other units also began to be frequently blocked, and the disturbance treatment was invalid by closing the valve back and forth and opening the full ammonia injection regulating valve, sometimes two or three times should be cleaned in one day. Spraying ammonia valve block position in the valve core, the shrouded (similar to the restrictor), a blockage to dark brown or khaki, block and powder, have certain adhesion, block can crush, clogs in addition to some unit with gray block, there is a little black particles (see figure 2, 3).

Figure 2. Brown black blockage in the ammonia injection control valve.

Finding out the cause of blockage is the key to solve the problem. First of all, the sampling analysis of all the injected ammonia control valves. The plugging material can be adsorbed by magnet. The ammonia smell is very heavy and oily, indicating that there is iron or iron oxide in the plugging material. A small amount of plugging material was taken for water solubility analysis. About half of them are volatile matter. The other half are granular residues that are completely soluble in hydrochloric acid and are basically iron oxides. It can be inferred that oxides are the corrosion products of ammonia equipment. The fouling samples were sent to Jiangsu provincial power research institute for further scale analysis, and the burn reduction was 50.5%, and the residue composition was shown in table 1.

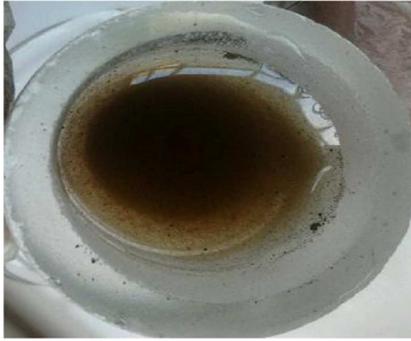
Figure 3. Khaki blockage dissolved in water.

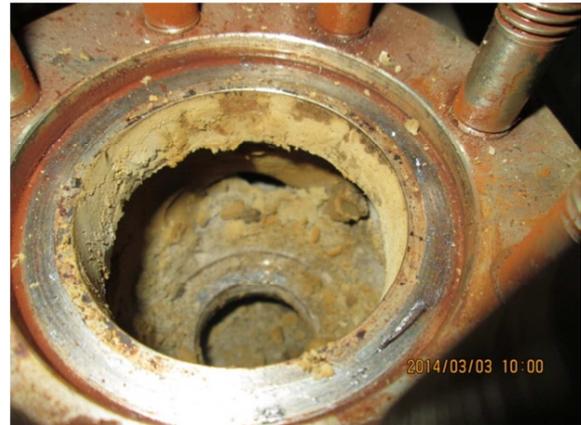
The factory used spraying ammonia regulator is shrouded type throttle valve, up and down through the control valve core position, control over all round orifice size to realize automatic spraying ammonia flow rate adjustment, regulating valve jams cleaning before and after pictures as shown in figure 4, 5. As can be seen from figure 4, the blockage mainly occurs at the throttle hole of the regulating valve. Ammonia valve throttling cover in the factory there are three kinds of structure (see figure 6~8), No. 13 and No. 14 units using the structure before retrofit, No. 9 and No. 10 units using the first transition structure, No. 11 and No. 12 units using the 2nd modification of structure. No. 9 and No. 10 units put into operation after spraying ammonia valve occasionally congestion, No. 8,11 and No. 12 units of commissioning spraying ammonia valve has not occurred since the congestion, enveloped to remove the original frames, the original four directions of three small throttle a large orifice. The denitrification transformation time of unit No. 8 is the latest, and the regulating valve is the same as unit No. 11 and No. 12. Before unit No. 8 was put into operation, because the ammonia supply pipeline was empty for a long time, high temperature steam and compressed air were used to clean the pipeline.

Figure 4. Ammonia injection control valve cover before cleaning.

- (5) For the units that have been blocked by the ammonia injection regulating valve, replace the regulating valve and adjust the flow rate from the original throttle cover to the valve stem valve core opening. When the ammonia injection regulating valve is cleaned, the door core and shroud must be cleaned, otherwise the remaining plug will adhere to the oily substances in the gas ammonia, causing the valve to be fouled again quickly. At the same time, ammonia gas can be used to purge the pipeline, control the time, prevent the escape rate of ammonia from being too high, prevent the corrosion of ammonium hydrogen sulfate and block the air preheater. [10]

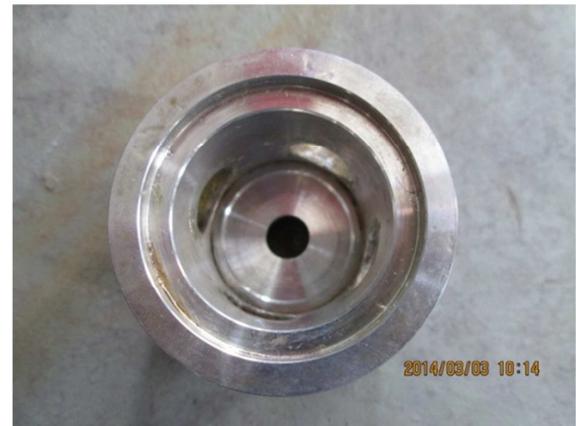
Figure 5. Ammonia injection control valve cover after cleaning.
