The Agricultural Environment's Effect on the Deterioration of the Archaeological Sites Applied on Atfiyah's Sarabium Archaeological Site – Egypt

Abstract: The Agricultural Environment has a severe effect on the deterioration of the archaeological sites, it causes many deterioration phenomena to these sites, most of them are biodeterioration and the others are physio – chemical deterioration. Sarabium archaeological site located in Atfiyah's center – Egypt, it belonged to 26th dynasty, the site suffers from the agricultural environment's effect because it is very near from the fields in the area (100 meter approx. far only). The most effective factor of deterioration is the groundwater which affects badly on the deterioration of the building materials there, many microorganisms grow on lime stone carved coffins and ruins, they secret organic compounds which react with lime stone and turn it to soluble salts, the groundwater comes from the fields and contains many salts which dissolve in it and rise with the capillary system to the building materials not only this effect, but also the intensive growth of weeds in the site. This research aims to study the agricultural environment's e

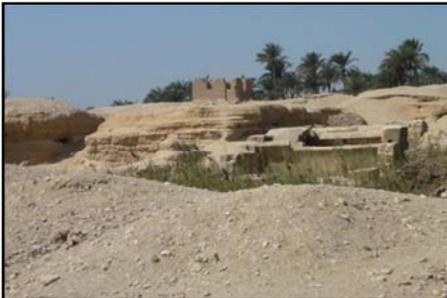
Figure 14. Shows an overview of Sarabium's archaeological site, fields are very near to the site.

(1) The groundwater's type in Atffiyah's Sarabium Archaeological site is Agriculture waste water due to the existence of sulphates and chlorides with high percentages, also the existence of coliform bacteria which live in the wet soils with high contamination, site is very near to the fields (100 meter far approx.) and the site is lower than the surrounding area, the agriculture waste water aggregates in the most lower point in the archaeological site (limestone' coffins).

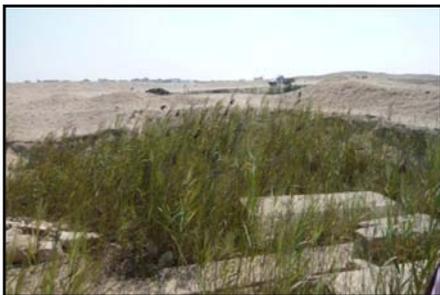
Figure 15. Shows the wide growth of weeds in limestone' coffins area in Sarabium archaeological site.

(13) The existence of the agriculture waste water in the site causes the high growth of some weeds like *Phragmites communis* (Trin.) and *Sonchus oleraceus* (L.) [3].

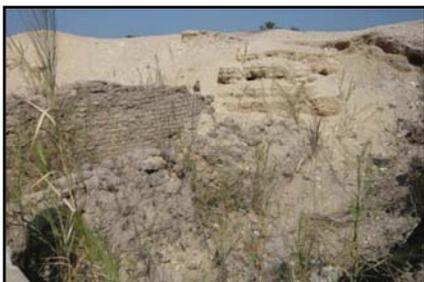
Figure 16. Shows the growth of weeds in mud bricks' ruins area in Sarabium archaeological site.

shows that mud bricks are very weak in the site because of the high percentage of quartz in them and the wide growth of weeds which penetrate deeply in mud bricks walls ruins and destroy them.

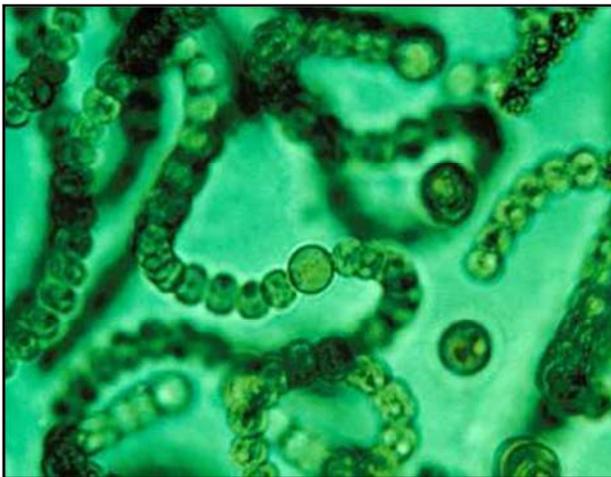
Figure 17. Shows the blue green algae under the microscope.

(11) The identification of the Microbiological effect of the groundwater shows the existence of blue green algae (Cyanobacteria) and diatoms (Bacillariophyceae) in the water, the transmission and growth of these microorganisms in the limestone's coffins and ruins' surface), the blue green algae and diatoms grow in the existence of sunlight to make photosynthesis.

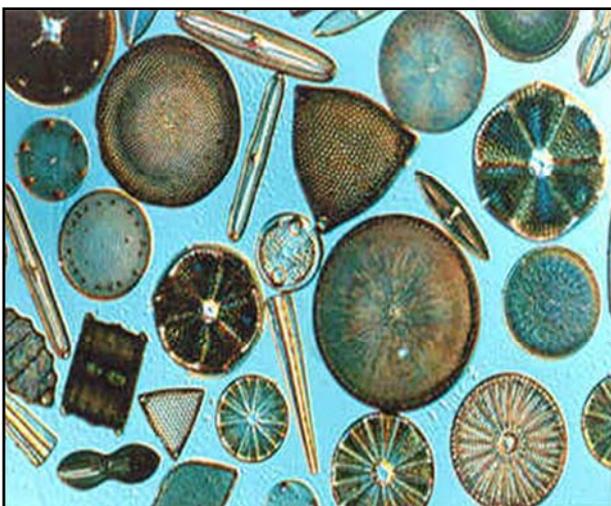
Figure 18. Shows the diatoms under the microscope.

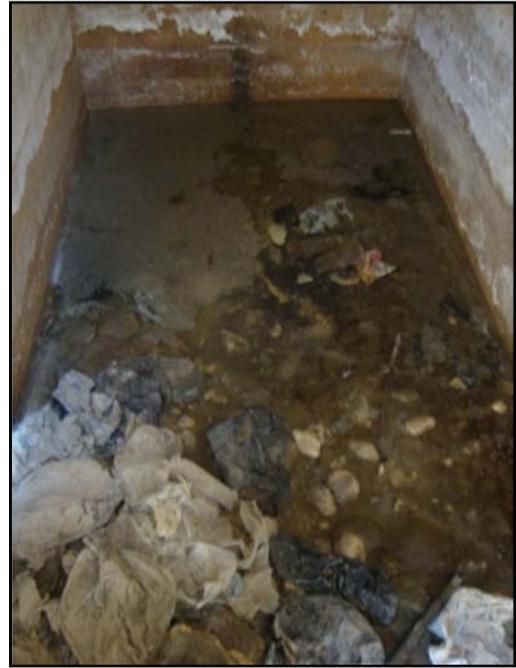
Figure 19. Shows the agriculture waste water aggregates in one of the limestone' coffins in the site.

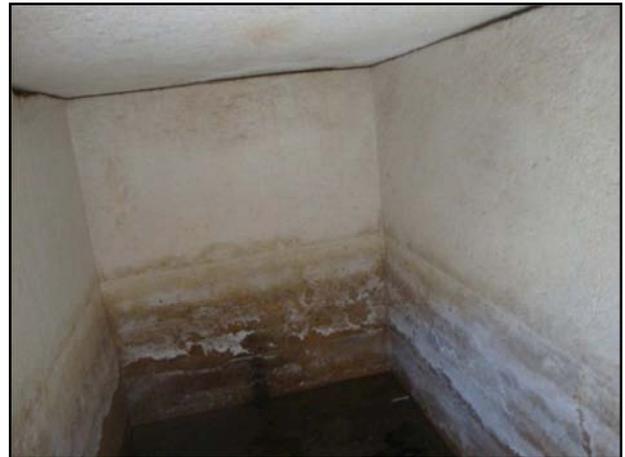
Figure 20. Shows growth of salts and algae inside the limestone's coffin.

(12) The organic activity of the algae consist biofilm which deforms the limestone's view by their stains, also the algae fix the carbon and provide a source of nutrition for heterotrophic microorganisms which may further degrade the stone 's surface (bio weathering of the stones) [2], Figure (17-22).

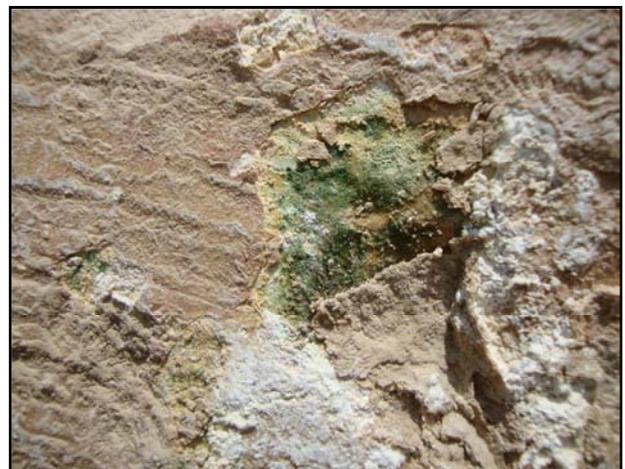
Figure 21. Shows the growth of algae on one of the limestone' ruins surface in the study area and staining of it.

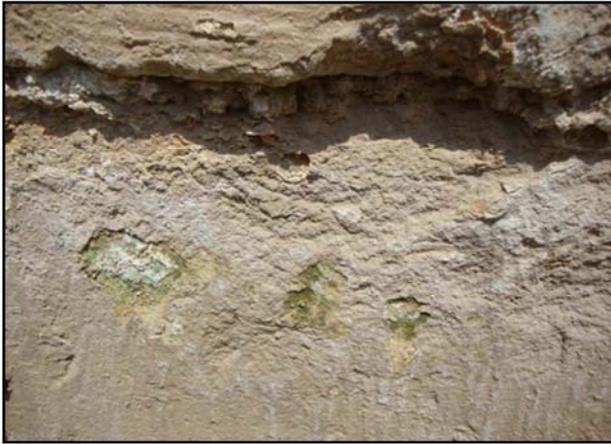
Figure 22. Shows the growth of algae on the external surface of one of the limestone' coffins.
