# Unexpected Seismic Damage vs. SLS Building Code Anomalies

Thomas Allan Moore

Structural Engineering Division, IDS, Dunedin, New Zealand

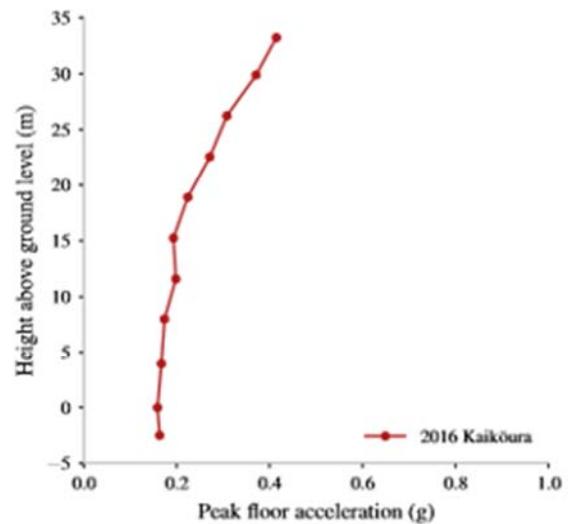
Figure 1. MBIE building, transverse floor accelerations, Nov 16. Credit [6].

The MBIE building in Wellington on class C soil [6], had a calculated period of 0.8 seconds and experienced a PGA of approximately 0.2G. It is shown in Figure 1 that a maximum peak floor acceleration of 0.4G was recorded at its uppermost level. Mostly only non-structural damage was reported in the MBIE building [4].

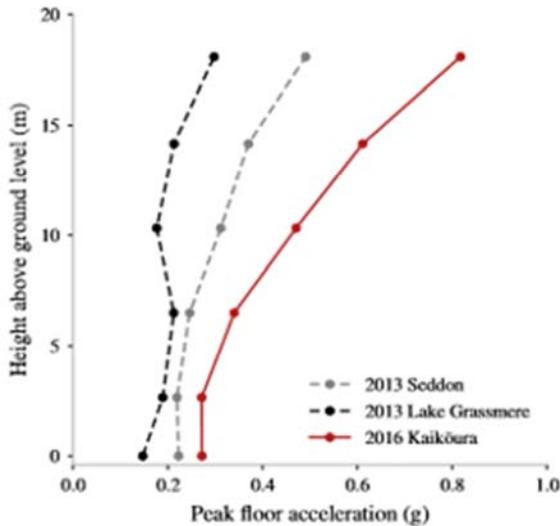
Figure 2. BNZ building, transverse floor accelerations, 3 EQs. Credit [6].

In contrast to the relatively good performance of the MBIE building, the BNZ building (founded on softer soils,) was designed for 1.6 to 2.5 times the demand for softer class D and class E soils than for firmer class C soils, but was severely damaged. The BNZ building experienced a peak floor acceleration of approximately 0.8G at its roof as shown in Figure 2.

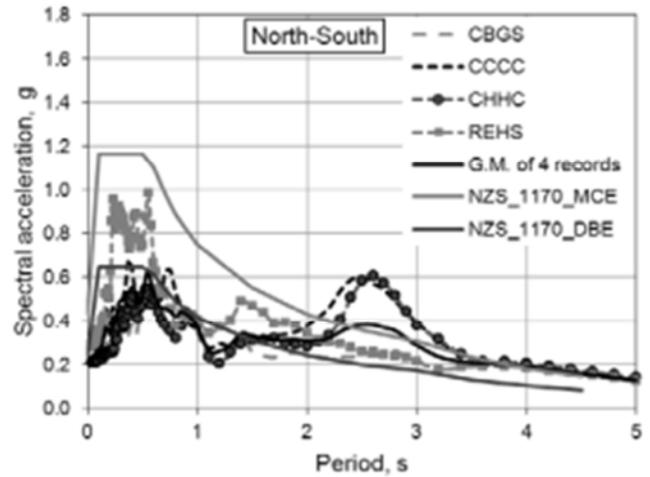
Figure 3. Acceleration Spectra at Christchurch Hospital (CHHC) and City Council Building and the Resthaven Home REHS from the 4 September 2010 EQ vs. MCE and ULS at  $Sp = 1$ , Ductility = 1, Soil D. Credit [15].

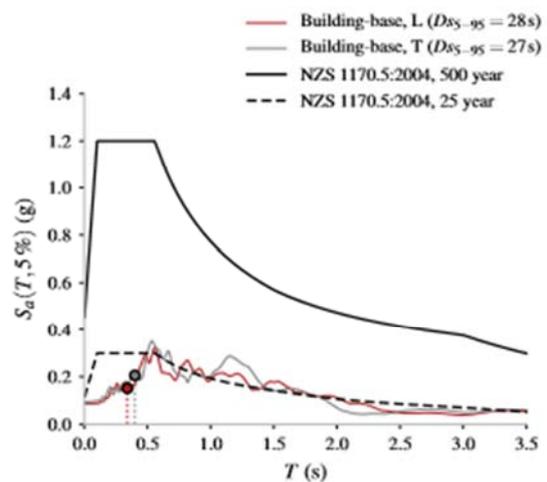
Figure 4. GNS Science Building versus 25 year SLS (dashed), class D soils. Credit: [6].

These recorded site ground motions shown in Figures 4, 5 and 6 are estimated to correspond to a 25 year event that resulted in mostly non-structural damage on class C and D soils – but resulted in more damage than would have occurred overseas with a 25 year recurrence EQ when international building codes have a 40% or larger design SLS forces.

Figures 4, 5 and 6 show typical ground Spectral Accelerations (SA) at firmer sites (but sites nearby to Statistics House,) were small to moderate - were in the range of 0.15G to 0.3G, and generally 0.15G to 0.18G - at a period of 0.8 seconds on class D soils. This compares with the similar 25 year SLS design SA of 0.16G to 0.23G at ductility of 1.0 for SLS at a range of  $Sp = 0.7-1.0$ .

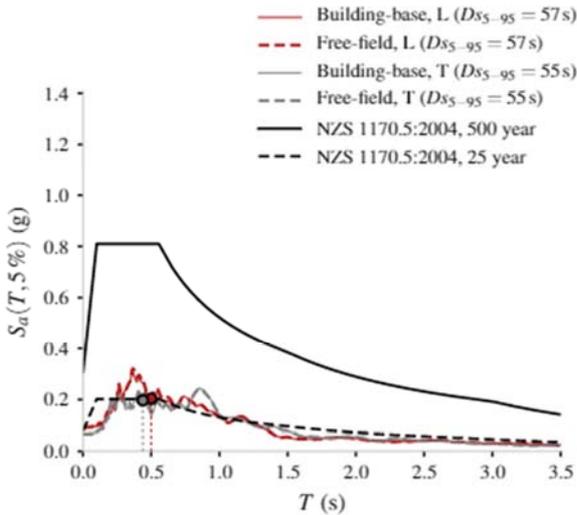
Figure 5. Recorded Ground Motions vs. dashed 25 year mini-SLS with  $Sp = 0.7$  for NMIT Buildings. Credit: [6].

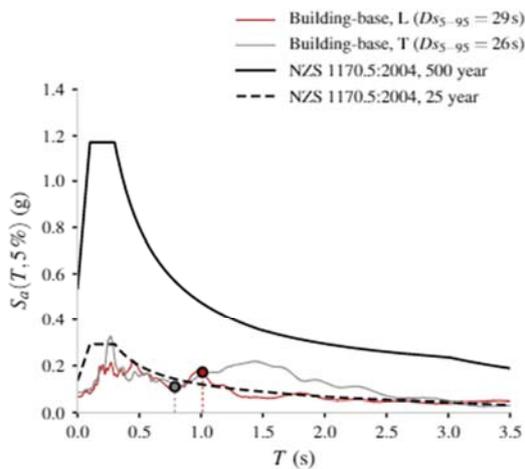
Figure 6. Response Spectra at Wellington Hospital, from November 2016 EQ, compare with 25 year mini-SLS (dashed) at ductility=1.25 and  $Sp = 1$ , vs ULS Spectra at.

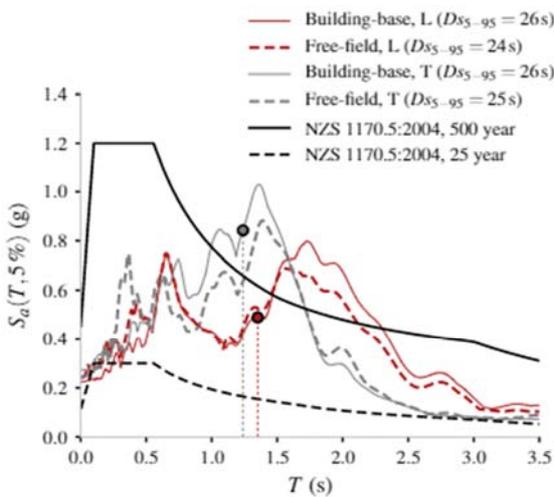
Figure 7. Response spectra for the Wellington MBIE Building for the November 14 2016 EQ compared with 25 year mini-SLS at  $Sp = 1$  and ductility= 1.25 per NZS 1170.5:2004 vs. 500 year ULS at  $Sp = 2$  and ductility = 1, assumed Soil type D Credit [6].

Figures 7 and 8 show the recorded ground motions from the 2016 seismic event on assumed soft class D soils - or very soft class E or Thorndon Basin soils, are shown in to be approximately 50 percent larger than the 25 year SLS event with  $Sp = 0.7$  ('mini-SLS'). The Figure 7 motions for the MBIE site correlate well with the class E soil SLS spectra. These larger ground motions are estimated to correspond to a 50 year event that would not have resulted in significant damage overseas when 50 year (or even 100 year) international SLS building codes having at least a 40% or greater design SLS force.

The recorded Spectral Accelerations (SA) shown in Figures 7 and 8 were greater, equal to approximately 0.33G per Figures 7 and 8, at a period of 0.8 seconds and located on the undesirable site soil amplifying conditions of the Thorndon Basin [4-6] This recorded motion is 50% larger than the comparable SLS motion at assumed class E soils of 0.21G for  $Sp = 0.7$ . The recorded motions for many Wellington CBD softer soil sites indicated several cycles of inelastic demands, (see Figures 7 and 8.) However, there is reportedly no apparent relationship between the damage and whether or not the building was located on reclaimed land [5].

nearest to the Statistics House site (and others in the Wellington region) per Figure 7 (to a lesser extent,) and Figure 8. Basin-edge effects had been suggested as a potential damage issue. NZS1170.5:2004 does not require basin-edge effects to be considered. However, it is suspected that the ground motion at Statistics House was amplified because seismic waves refracted off the perimeter of this localised geological basin [4].

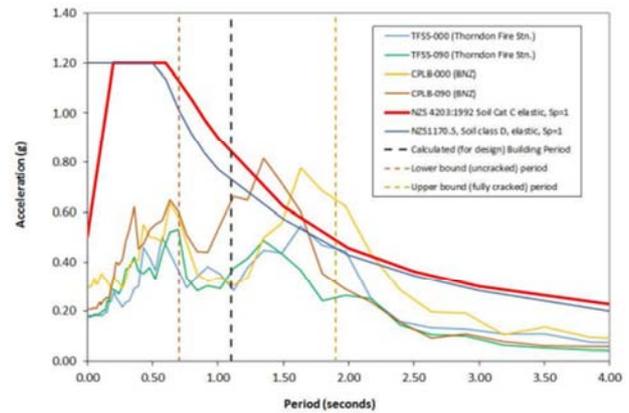
Figure 8. 5% damped acceleration response spectra at Thorndon Fire Station and BNZ Building strong motion stations vs ULS,  $Sp = 1$ , Ductility = 1, Soil type D assumed to calculate ULS. Credit [4].

The damage from ground motions recorded at nearby Thorndon Basin deep soil sites shown in Figure 8 correlate with a class E soil - that are considered to represent an upper bound to the ground motions experienced at the Statistics House site during the November 14 2016 EQ [4] This is based on their generally similar soil profiles and geology, source-to-site distance, and close distance (<2km) to Statistics House.

Although it is evident that amplification of ground motions occurred on some sites containing thick deposits of soft soils, including those associated with reclaimed land, such amplification, as shown in Figure 8, is not believed to have been significant at the Statistics House reclaimed site [4]. However, it may have been at a few other Wellington sites and resulted in greater damage compared with Statistics House.

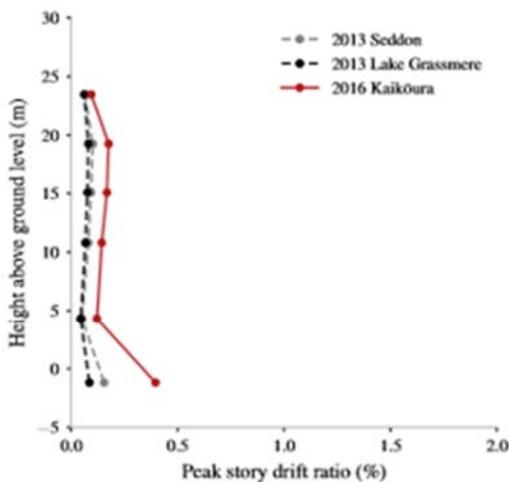
Figure 9. Inter-storey Drift from 3 Wellington EQs - 2013 Seddon, 2013 Lake Grassmere, November 14 2016 Kaikōura, at Wellington Hospital. Credit: [6].

The peak Storey Drift Ratios SDRs in Wellington Hospital and the MBIE building are shown in Figures 9 and 10, and were generally 0.2 % over the entire height of the building – with localised exceptions. There was no major structural damage and mostly non-structural damage [5], as expected at conforming drifts. However, the BNZ building (Custom Quay,) experienced a maximum peak SDR of 1.8 % at the third floor [6], on Thorndon Basin soils, as shown in Figure 10. This indicates the building lacked adequate stiffness. Substantial damage was suffered.

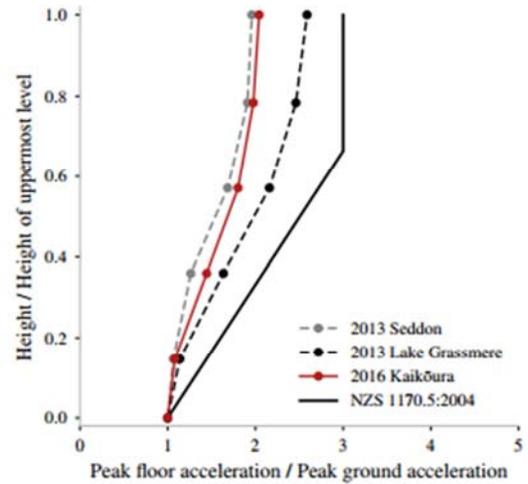
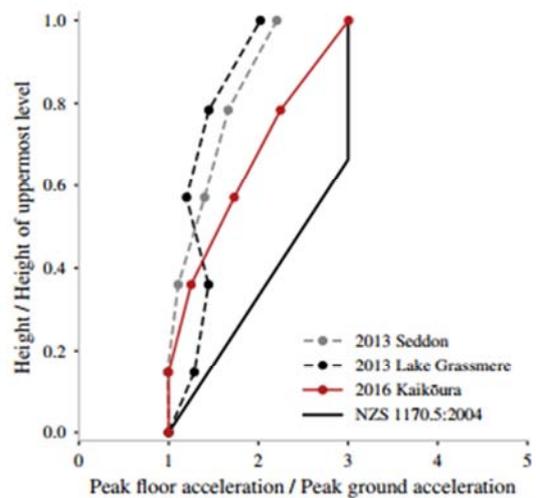
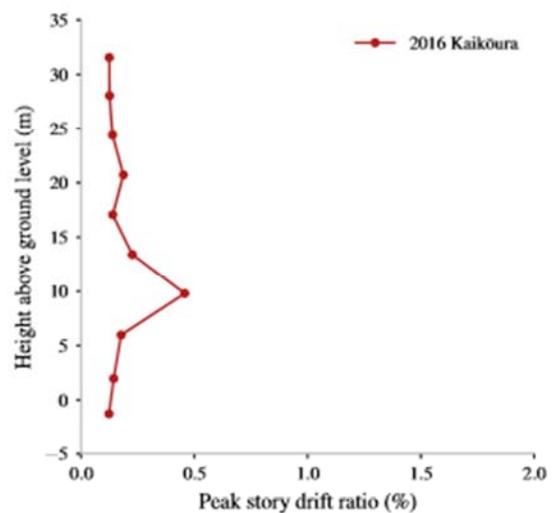
(a) BNZ building (longitudinal direction)

(b) BNZ building (transverse direction)

(c) MBIE building (longitudinal direction)

Figure 10. Inter-storey Drift of BNZ and MBIE Buildings recorded from November 2016 Ground Motion. Credit [6].

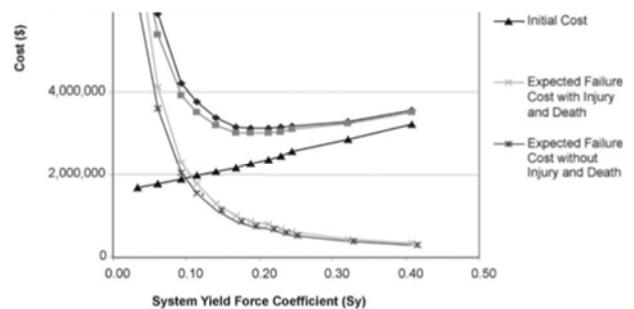
Figure 11. Initial Structural Shell Construction Cost versus Lateral Seismic Force for nine story steel frame building in Los Angeles CBD, 2001. Credit: Wen [21].

When  $SA = 0.08G$ ;  $IC_1 = \$2190/\text{sq. m.}$

When  $SA = 0.17G$ ;  $IC_2 = \$2395/\text{sq. m.}$

The increased cost  $IC_2 - IC_1 = \$205/\text{sq. m.} = 9\%$  of the initial cost IC for the 100 versus 25 year event in Wellington.

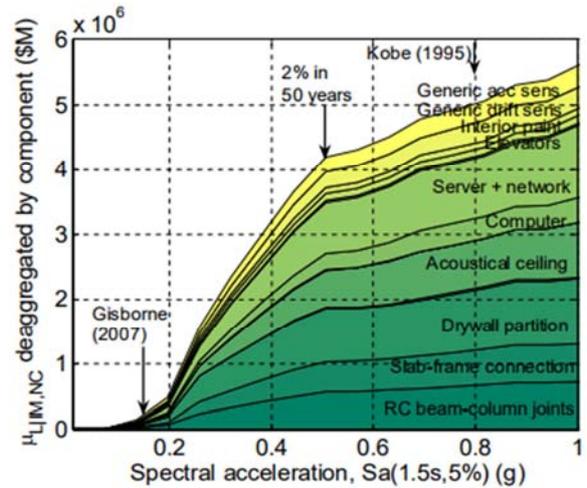
**Figure 12.** De-aggregation of the mean direct loss given no collapse relationship to contributions from different components. Credit: [20].
