Seepage phenomenon for Wadi Megenin dam

Abstract: Most of the recorded dam failures in different parts of the world were related to seepage problems. Avoiding earth dam's failure due to seepage usually requires evaluating settlement, and piping, through field monitoring. The problem of dam seepage was experienced in The 38 m high rock fill Megenin dam is a at located at Souk AL khamis area 75 Km south of Tripoli. The dam was constructed in 1972, for two main purposes; to provide flood controls of the downstream areas, the cultivated fields and Tripoli city, and also provides water for irrigation purpose . The rock-fill dam was supported with an upstream reinforced concrete membrane on the upstreamface consisted of a number of concrete panels, linked together with central rubber water stops, and surface-sealed with a bituminous sealant. A concrete cut-off wall and grout curtain were constructed below the dam body to prevent reservoir seepage through the foundation. It was observed during the 3rd filling of the reservoir at the reservoir storage water level at +271.86 m on 15th May 2003, seepage occurred at the wadi bed downstream of the main dam. The seepage occurred at a piezometr

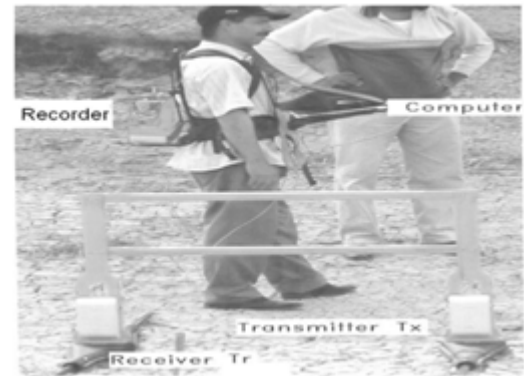
Figure (6): GPR system used in Megenin dam

Surveys were carried out in April and June, 2007 by the tools as shown in figure (6). The dam reservoir was dry with bed surface elevation of 263 m (a.s.l), used for surveying different TWT (Recording two-way time) of 1000 nanoseconds. Twelve profiles were made mostly parallel to the dam axis, and run on the bed of the reservoir
