# The Impacts and Implications of Anthropogenic Forces on the Unstable Geologic Platform in Parts of Anambra and Imo States Southeastern, Nigeria

Department of Geological Sciences, Nnamdi Azikiwe University, Awka, Nigeria

Egboka Boniface Chukwuka, Okoyeh Elizabeth Ifeyinwa. The Impacts and Implications of Anthropogenic Forces on the Unstable Geologic Platform in Parts of Anambra and Imo States Southeastern, Nigeria. *International Journal of Environmental Protection and Policy*. Vol. 4, No. 4, 2016, pp. 104-110. doi: 10.11648/j.ijepp.20160404.12

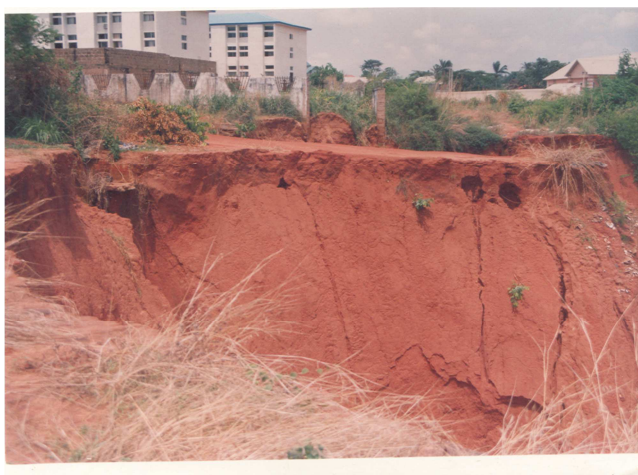
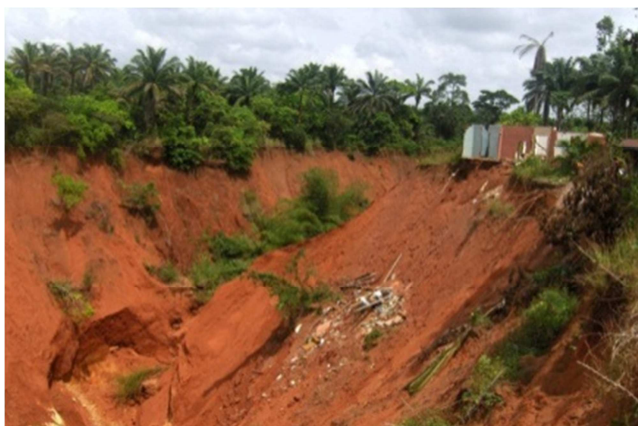
*Fig. 5. Gully sites and associated socioeconomic lossess.*

Despite the above potential environmental instability, governments and people have been carrying out massive development projects in these areas. The lands and environment along the Agulu-Nanka cuesta are geologically and geotectonically quite unstable and should be regarded seriously asuch in planning and executing development projects. Residential houses, commercial centres, road networks and drainages stretch far down into the lowlands/valleys. Buildings are seen perching perilously at the edge of gullies ready to be thrown into the valley at the least moment of adjacent gullies or landslides (Plate 1 and 2). Some of the frontal areal lengths of the aggressive fingers of gullies are advancing into the urban heartlands at the rates of between 2 and 3 m per year while expanding at their widths at about 3 to 5 m wide annually approaching the major roads or have cut them in places.
