# Roundabout Accessibility: A Canadian View

Department of Civil Engineering, Lakehead University, Thunder Bay, Canada

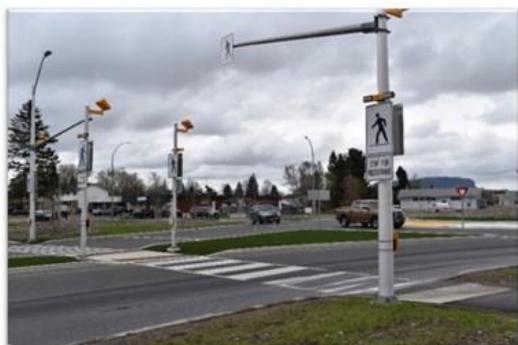
Figure 2. Rectangular Rapid Flashing Beacon (RRFB) with an Accessible Pedestrian Signal (APS) and push button on the pole, Thunder Bay.

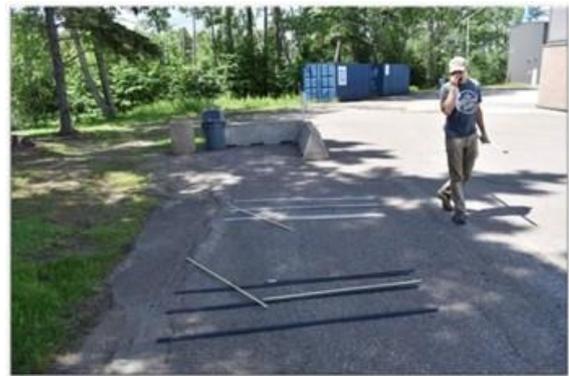
Figure 4. Pieces of strips and dowels displayed in the back of the laboratory.

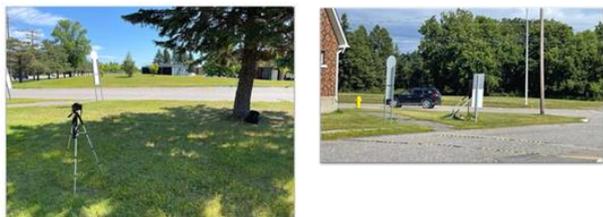
**Figure 6.** Camera mounted on a stand at the entrance of parking lot (LHS). Strip-dowel assembly plastered to the pavement's surface (RHS).

To evaluate the sound strip installation technique, the research team conducted a trial assessment of the required installation time, performance, strength, and durability under various weather conditions. A test installation was set up in a parking lot on the Lakehead University (LU) campus, where the speed limit is 25 KPH. As shown in Figure 6, the setup

consisted of two rows of strips, spaced 4 meters apart, simulating the intended roundabout configuration. A camera recorded vehicles passing over the strips, allowing researchers to estimate vehicle speed based on the time taken to travel a known distance. This setup enabled the evaluation of the strip's effectiveness at low speeds and determination of the maximum audible distance of the sound produced.

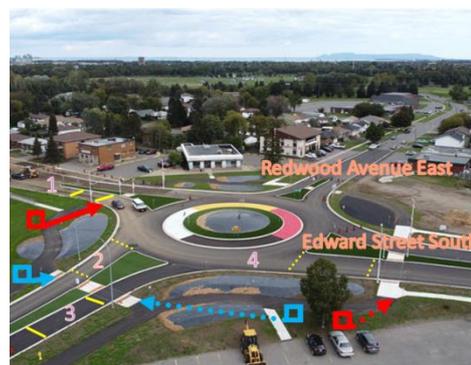
**Figure 7.** Showing Approaches and position for camera on the roundabout. (Photo Credit: City of Thunder Bay).

Data collection commenced on Edward Street's north side with southbound traffic, proceeded to Redwood Avenue's west side for westbound and eastbound traffic, and concluded on Edward Street's south side with southbound traffic. At each approach, volunteers made three crossing attempts, accompanied by a CNIB orientation and mobility specialist and a research team member. Each attempt was recorded by cameras positioned at each approach, as illustrated in **Figure 7**. This figure depicts the

four considered approaches, with camera positions marked by red and blue squares, indicating the direction of the major and minor roads, respectively. Solid and broken lines with arrowheads represent the camera's vision field, monitoring the respective quadrants. Yellow lines in **Figure 7** indicate the sound strip rows, with solid lines on inbound approaches 1 and 3, and broken lines on outbound approaches 2 and 4. The collected data included measurements of time spent activating the Accessible Pedestrian Signal (APS) and waiting for vehicles to yield, as well as instances when volunteers detected approaching vehicles and determined they had yielded.

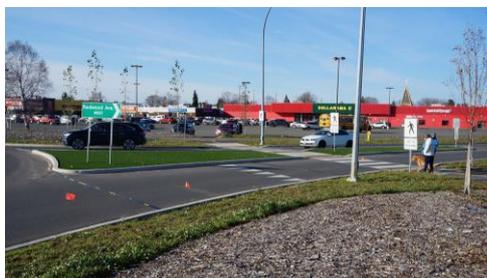
Figure 9. Two rows of strips installed, with three red flags positioned along the side of the road.

To facilitate data collection, red color flags were utilized on the field. **Figure 9** illustrates the positioning of these flags on the approach leading to the crosswalk. The figure shows the placement of the three flags: Flag 1, Flag 2 (aligned with the

first row of sound strips), and Flag 3 (positioned at the second row of sound strips), followed by the crosswalk. These three red flags enabled easy tracking of vehicle movement.

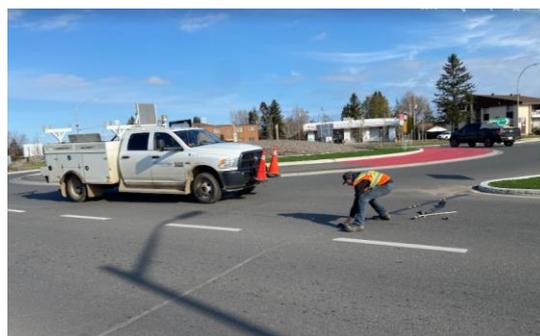
Figure 11. Removing the strip and cleaning up.

After completing data collection, the research team and Lakehead University colleagues removed the sound strips and accessories, cleaned up the site, and restored the road to its original condition. Meanwhile, City of Thunder Bay staff provided traffic control support. This collaborative effort is illustrated in Figure 11.

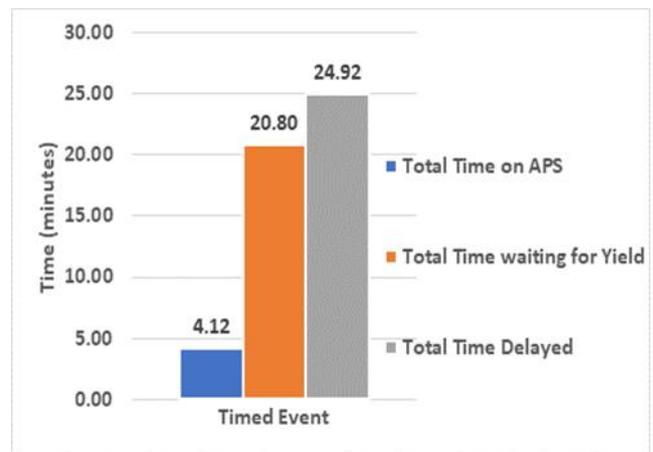
Figure 18. Showing the time spent by the pedestrian to activate the RRFB with APS, the time spent waiting for vehicles to yield, and the total delay time at the crosswalk after the strip treatment was applied.

As shown in Figures 17 and 18, total time delayed considering Approaches 1 to 4 combined was 28.28 minutes for 41 attempts before the sound strip treatment, and 24.92 minutes for 39 attempts after the treatment. The data is presented collectively for the four approaches, as the focus is on the overall impact of the sound strip treatment on pedestrian delay times, rather than approach-specific differences.
