On-site Inspection of PV Panels, Aided by Infrared Thermography

Elias Roumpakias, Fotis Bouroutzikas, Anastassios Stamatelos

Mechanical Engineering Department, University of Thessaly, Volos, Greece

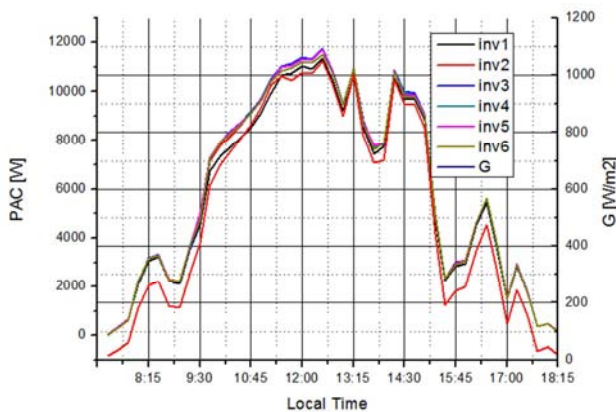
Monitoring data from the operation of the inverters installed on the PV park #1 (in which the faults presented in Figures 4, 6 and 15 were spotted) were collected and processed. The specific PV panel shown in Figure 6 is installed in the same series connected to Inv1. This specific inverter produces 5% less electric power than the rest of the inverters in this installation. This should be attributed to the faulty performance of the specific panel, because no deviation was observed in the past with these inverters. According to the above mentioned classification of hot spots, a temperature difference of 18°C may result in a 10% power loss. In the specific case, temperature differences exceed 35°C, however, the observed power losses are only 5%. This could be attributed to overproduction of the other panels in the string. Further investigation is needed. Moreover, another inverter, namely, Inv6 which is connected to PV panels shown in Figures 4, 15, produces 1% less electric power compared with the rest of the inverters (apart from the above-mentioned Inv 1). This slightly reduced electricity production

from this series could be due to the fact that several panels from this series present a yellowing of the EVA membrane. The diagram presented in Figure 20 shows the electricity production during the 3rd of March 2015, which was the specific day when the inspection with thermography took place. During the time interval from 11.00-13.00 where the infrared thermograms were received, it is apparent that the inverters Inv1, Inv6 produce less power. In order to confirm that this is a systematic deviation in performance, Figure 21 presents a diagram of the electricity produced during the first 10 days of March. The trend is clearly observable for all days.

Figure 20. Graph of daily electricity production of a 100 kW PV plant and solar insolation on March 3rd, 2015.

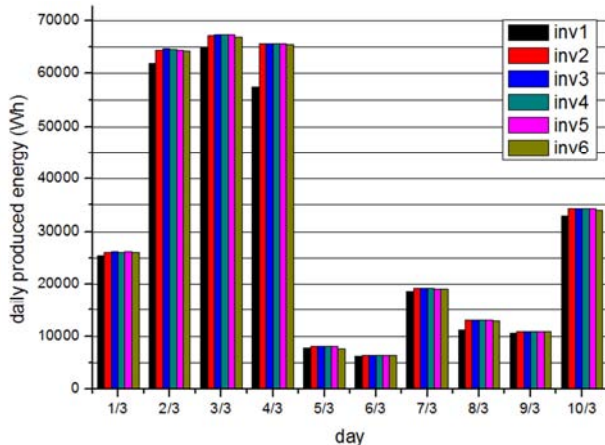
Figure 21. Electricity production of the same PV plant in the period from 1 to 10 March 2015.
