# Shear Zone Treatment at Dam Foundation Level

Ashutosh Anand, Somesh Kumar, Vivek Tripathi

Designs & Research Wing, Central Water Commission, New Delhi, India

Ashutosh Anand, Somesh Kumar, Vivek Tripathi. Shear Zone Treatment at Dam Foundation Level. *American Journal of Civil Engineering*. Vol. 5, No. 6, 2017, pp. 352-357. doi: 10.11648/j.ajce.20170506.16

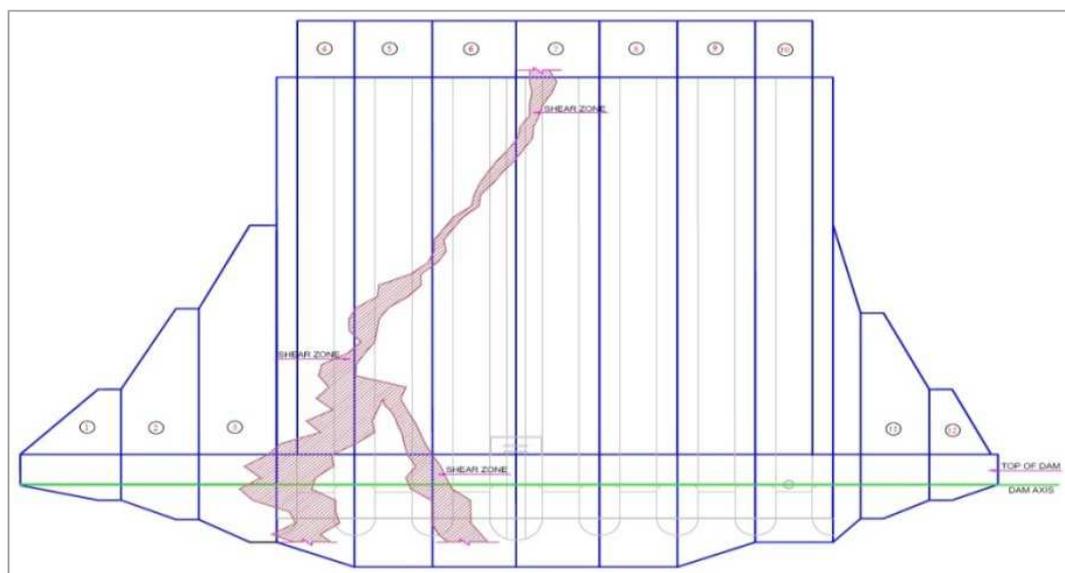
Figure 1. Dam Plan.

which is 86.00 m high and 213.50 m long. Foundation level of the dam is 34.5 m below from the bed level. The shear zone spreads below the overflow blocks 3,4,5,6 and 7 from upstream to downstream of dam axis (Figure 1).
