Numerical Modelling of the Slope: A Case Study of Dounia Park (North Algeria)

Abstract: In this study, we describe the landslide of Dounia Park, Northern the capital Algiers, exactly in the city of Dely Ibrahim, near the Mercedes house. It is regarded as a huge park with games, and the green lungs of Algiers. This study is based on the configuration of the slope, mechanical properties and soil class, geology intervenes in the relief geomorphology and stratification, water, and earthquake shaking, etc..., the field observation has revealed the existence of land instabilities, cracks, and types of landslides (translation, rotation), in order to examine the landslides of Dounia Park, numerical modeling by the finite element limit analysis is employed to investigate this slope. The results obtained in this article show numerous points. During the site visit, it was observed that the area of Dounia Park is affected by many types of instabilities. Also, this paper show adequately give out the morphology of the slope instability observed on the site.

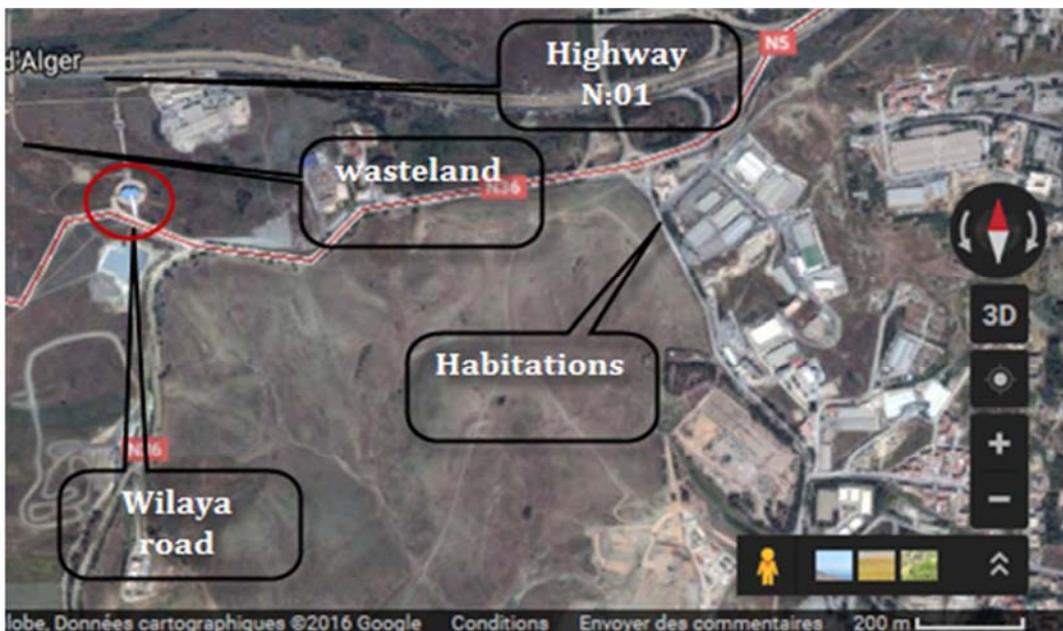
Figure 5. The position of Dounia Park, and its borders.

the north by Beni Messous, to the northeast by Bouzareah, to the east by Ben Aknoun, to the west by Cheraga, to the south by Oueld Fayat and El Achour, see figure 4. The Park, with a total area of 65 hectares, is bordered by Highway of national road No. 01, in the north, Wilaya road in the south, So far there are habitations, to the East, and the Rest of the field (wasteland) to the west (figure 5).

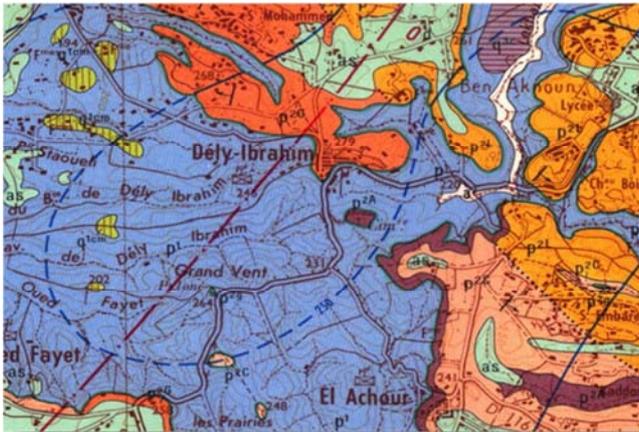
Figure 6. Geological formations from the card of Cheraga (at 1 / 50,000).

The geology of this area taken from the card Cheraga (at 1/50,000) [18], highlighted the geological formations of the

area, (figure 6). This region is sensitive to water, because it consists largely of marl. According to its degree of alteration, the plaisancian marl has different behaviors towards slope stability and its resistance to breaking.

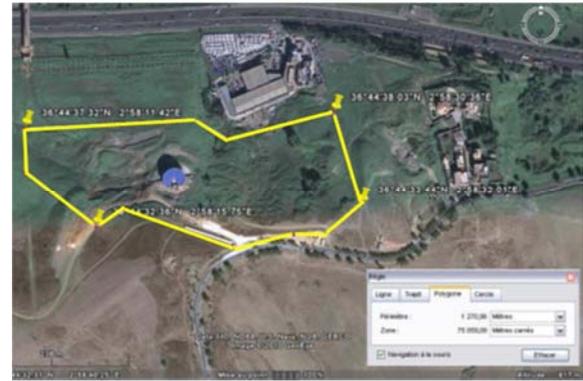
Figure 7. Limited area of geotechnical studies by the yellow color.

The results of the geotechnical characteristics obtained by the National Laboratory of Housing and Construction (NLHC 2011), Geotechnical studies of the slide area are indicated with the yellow color (figure 7). There are many results obtained by observations, insight investigations and in laboratory; the geotechnical characteristics are presented in table 1.

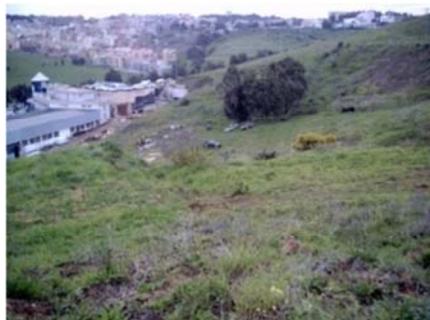
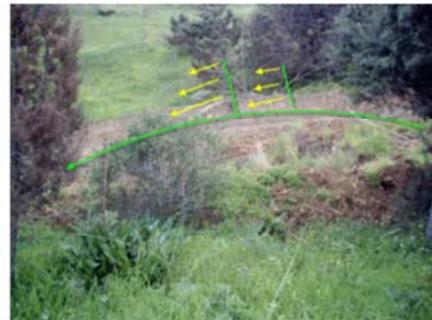
Figure 8. (a) The slope of our land, (b) The inclination of the trees.

Numerous field of information in and around Dounia Park revealed the existence of landslides, showing that this zone is prone to land instabilities. As shown in figure 8, there is a slope with a significant angle that makes slopes easy to be unstable in combination with other factors, such as water and earthquake. The trees (figure 8) confirmed the importance and the situation of our slope.

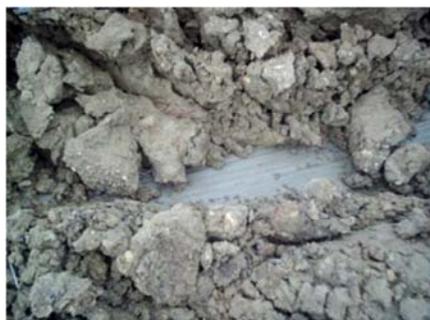
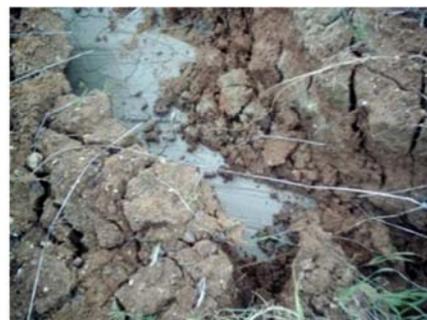
Figure 9. Examples on observations indicating the land instabilities.

The different results obtained by observations and insight investigations show the instability of the soils (figure 9), due to nature, behavior of soils and type of layers. The top layer

of fill slides on the lower layer of marl, there no interaction between those soils, due to the behavior and thickness of fill and the preset of water of rainfall.

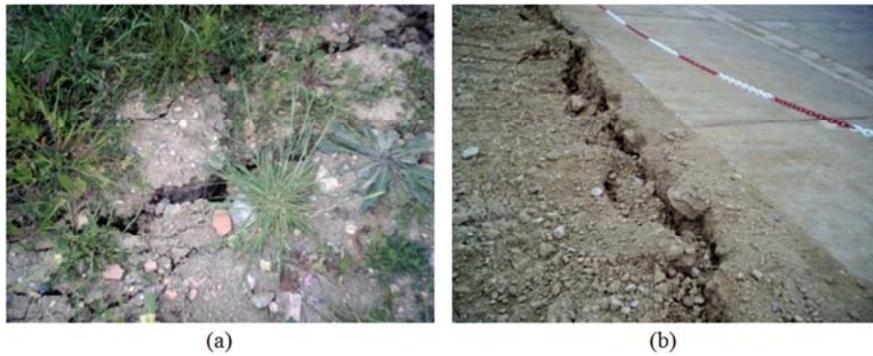
Figure 10. Fissures observed in the soil and near to the road N: 01.

During the site visit, different forms of instability were found, in which the scale varies from one place to another figure (10) shows various instabilities such as the first crack (figure 10 (a)), present in soil, this kind of cracks are everywhere. As mentioned previously, this is due to the

characteristics of soil (fill, marl). Figure 10 (b) and 11 show many observations revealed that discontinuity orientation was important in the instability of soil and road as shown in figure 11, large longitudinal cracks next to the road are traced. That cracks can be explained by factors such as human

causes (works in this area) and soil nature (marl and fill).

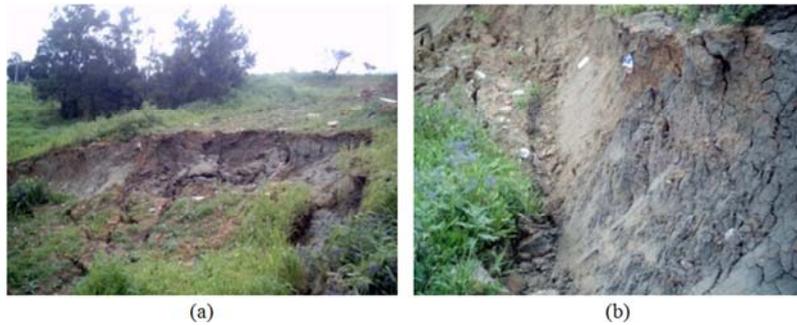
Figure 12. Observations indicating land instabilities, by the translational landslides.

This study area is affected by two categorizes of landslides due to the morphological types of the landslides, and according to the classification of Cruden and al [19]: translational and rotational slides, as we see in figure 12 and 13. The first is the translational slides, with highly variable masses, affected due to the marl and fill, and the angle of slope (figure 12 (a) and (b)). The second type of slides are rotational, they are shown in figures 13 (a) and (b). These landslides have different masses and rainfall plays the prominent role in this instability. The first type of slides (translational) are more gentle slopes compared to the second type (rotational) slope instability.

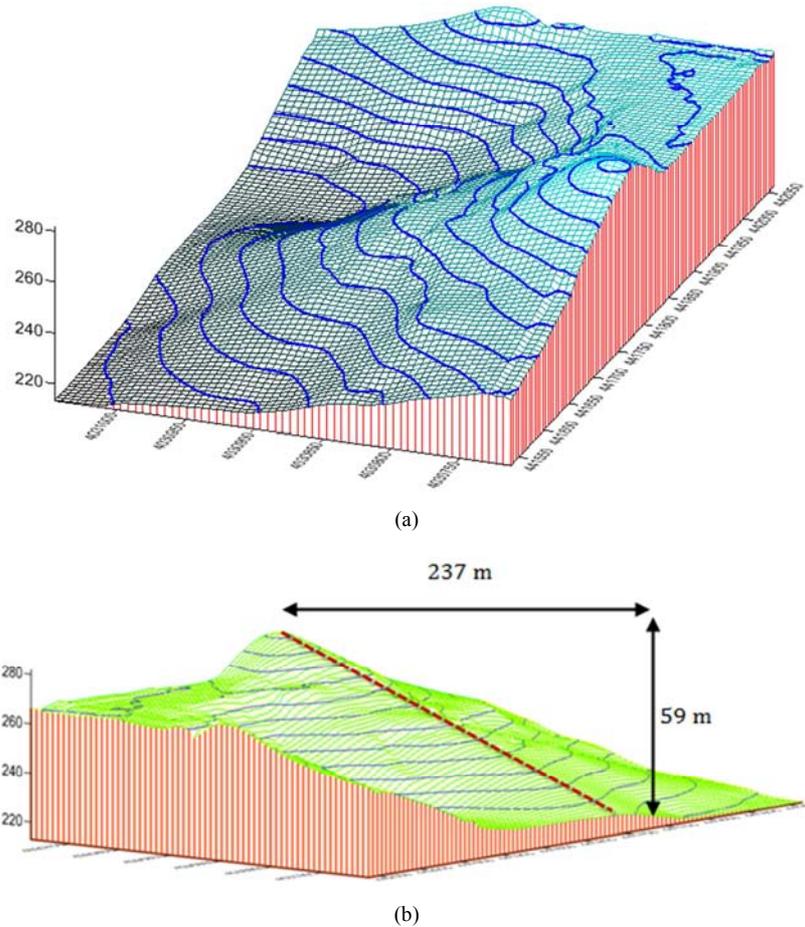
Figure 14. The view of the study area in 3D.

To analyze the slope we need to define the characteristics of the material and the geometry of the slide; this is assisted with the shape of the area that is presented in a 3D format. Figures 14 (a) and (b) show the total vision of this area, and

the most critical slope selected for analysis (figure 14 (b)), the length of this slope is 237 m, and the height is 59 m. There are three layers of soils, the landslide is simulate in a (2-D) two-dimensional with plane strain, the model of Mohr–Coulomb used to analyze this slope, all properties of soil are presented in Table 1.

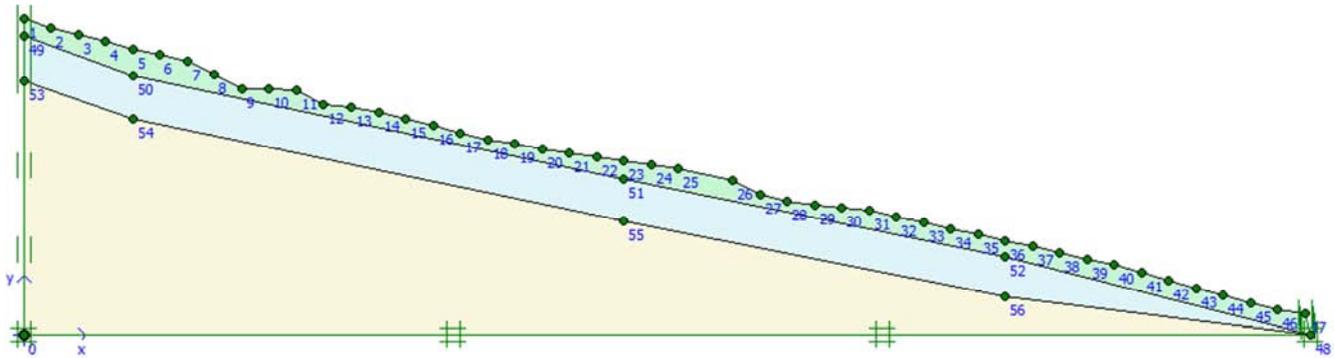
Figure 15. The slope geometry of Dounia Park in 2D.

Our modeling (figure 15) is founded on a shear strength reduction method (SRM) attached with the FEM, due to this method we can determine the factors of safety and failure mechanisms. We used the Mohr-Coulomb model to modeling this slope “Dounia Park.

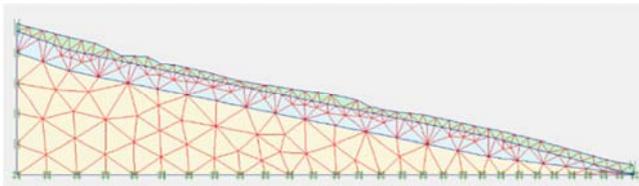
Figure 16. Meshed geometry by triangular elements.

The mesh selected for this modeling is constituted by triangular elements at 15 nodes (our profile contains 379

elements, and 3195 nodes) figure 16.

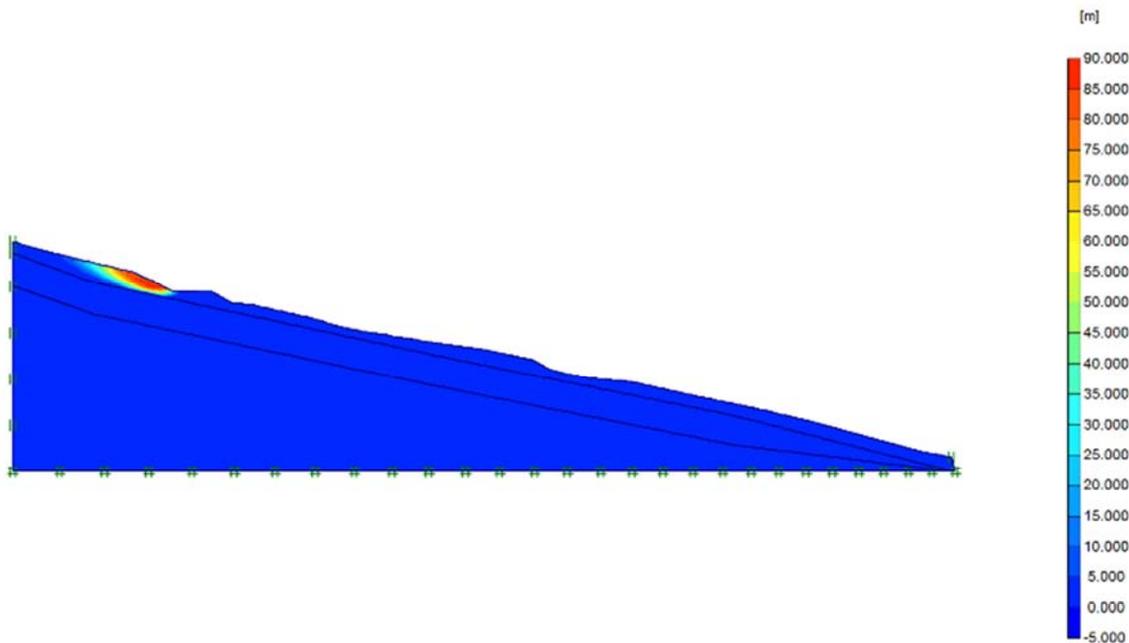
Figure 17. The critical slip surface.

The slope stability of Dounia Park is assessed under conditions of characteristics soils and the slope angle by the strength reduction method SRM attached with the FEM. This area is affected by many landslides as shown previously. Figure 17, shows the failure surface of the slope. The factor of safety in this slope is $FS=1.022$, we noticed the slope of Dounia Park is unstable in the top, the shape of this slide is a typical rotational landslide (figure 17).

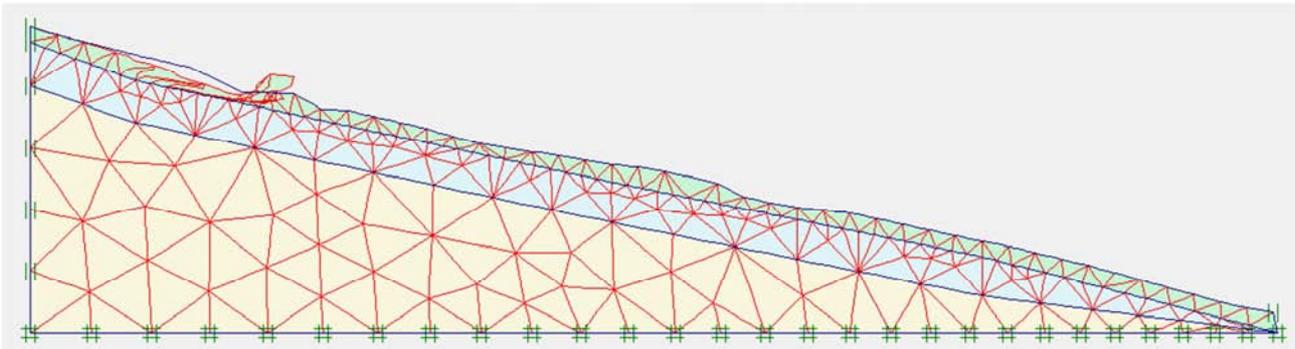
Figure 18. The failure surface by the mesh deformation.

In figure 18, the deformation mesh is presented, we note that the sliding surface take length of 41 m (figure 19). In addition, the sliding surface is just in the upper layer of the soil

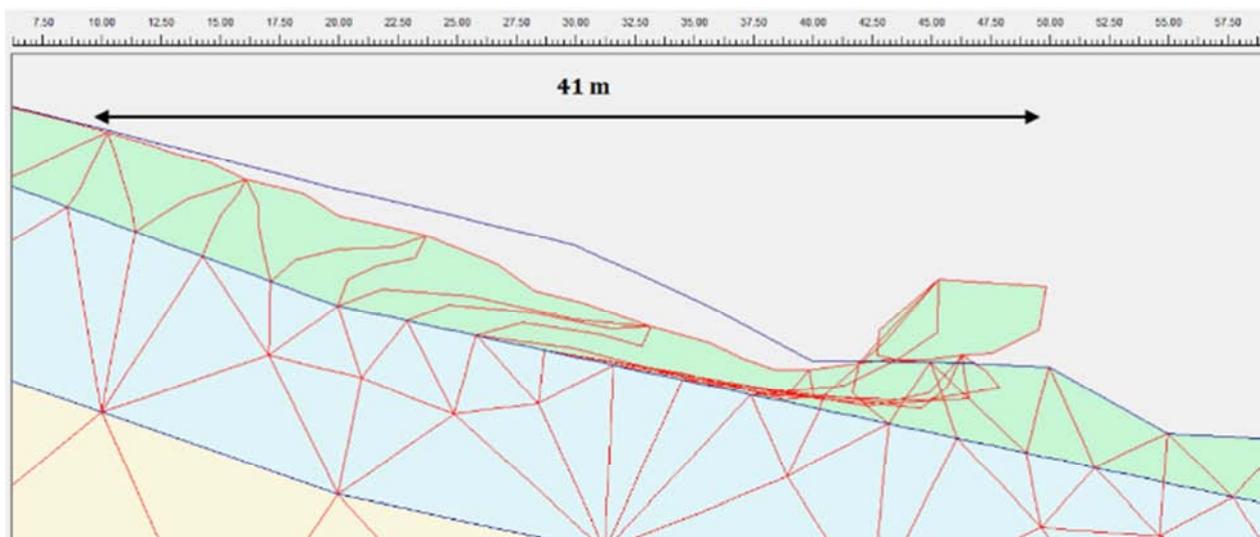
Figure 19. Zoom in the area of by mesh deformation.

(fill), see figure 19. As we observed previously in the area of Dounia Park during the site visit that confirms that types of soil play an important role in this slope.

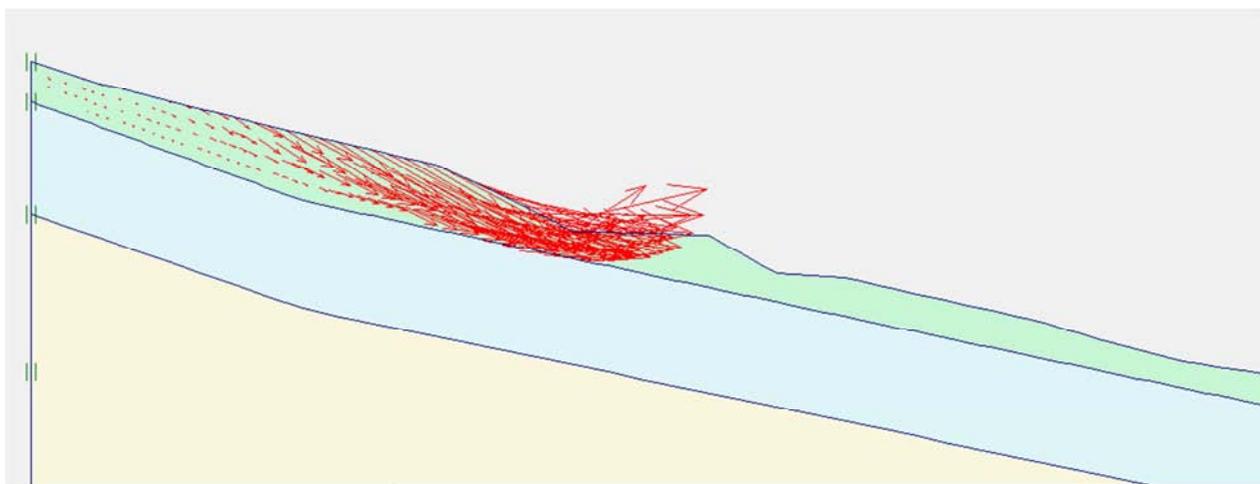
Figure 20. The failure surface by the displacement increments.

Figure 20 presents the displacement field of the slope analyzed by the equivalent M-C criterion. In this figure, it is clear that fill layer slides to the marl. This confirms and shows

the power of the SRM (strength reduction method) coupled with the FEM.
